## UAV-Based Bridge Inspection and Computational Simulations

UAV– BASED BRIDGE INSPECTION AND COMPUTATIONAL SIMULATIONS

A thesis submitted in partial fulfillment of the requirements for

Major in Civil Engineering

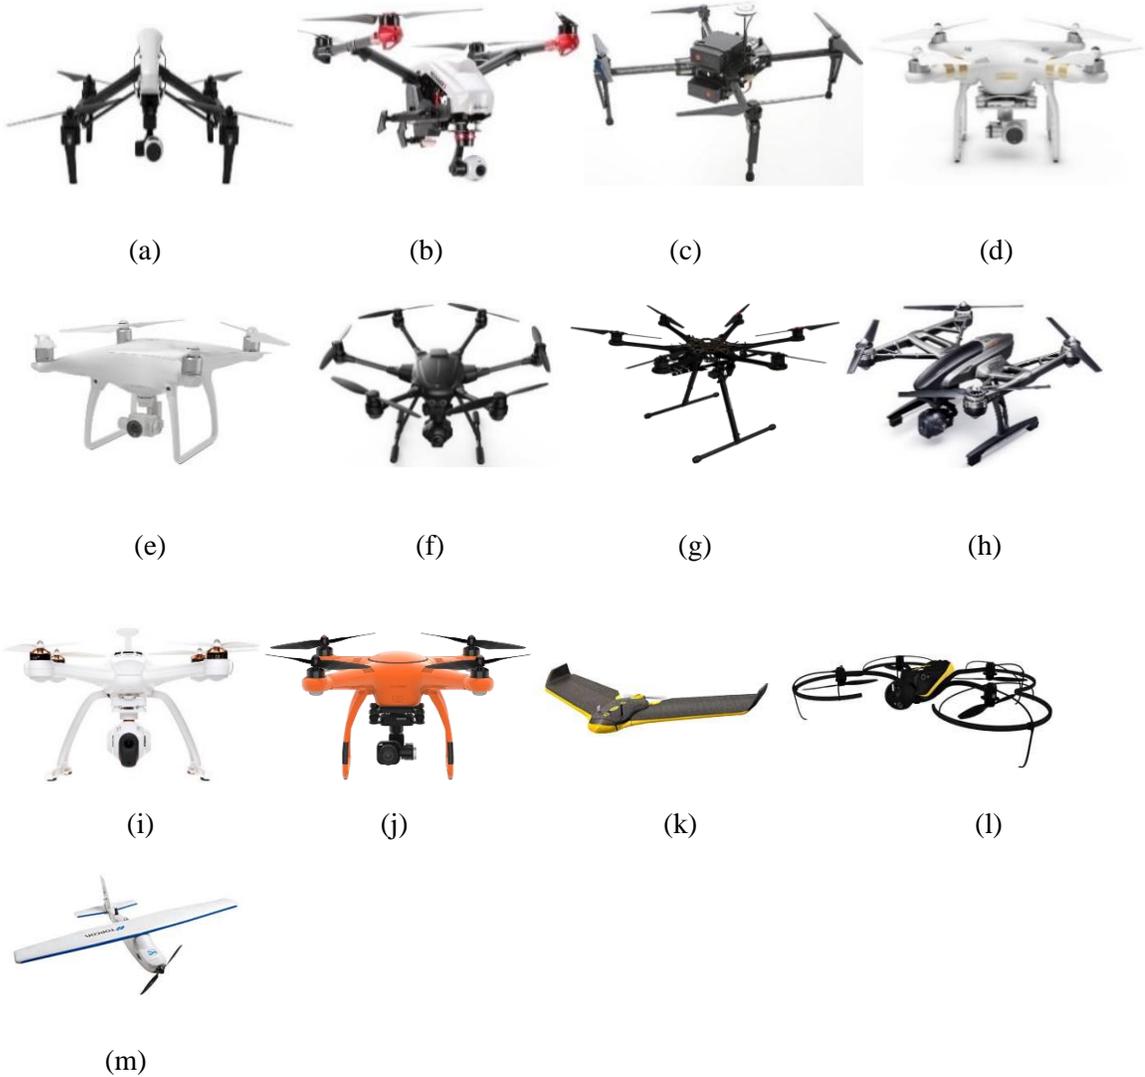
**Fig. 1-1.** Investigated drones: (a) DJI Inspire 1; (b) Voyager 3; (c) DJI Matrice 100; (d) DJI Phantom 3 Pro; (e) DJI Phantom 4; (f) Yuneec Typhoon H; (g) DJI S900 airframe; (h) Yuneec Typhoon 4K; (i) Blade Chroma; (j) Autel Robotics X-Star Premium; (k) SenseFly eBee; (l) SenseFly Albris; and (m) Topcon Sirius Pro.

Alternatively, options such as the DJI Matrice 100 (**Fig. 1-1c**), DJI S900 (**Fig. 1-1g**), DJI Phantom 3 Pro (**Fig. 1-1d**), and DJI Phantom 4 (**Fig. 1-1e**) were deemed to be suitable at a more affordable price compared to the Sensefly Albris. The DJI Phantom 4 was selected over the others due to its performance and versatility meeting the aforementioned specifications at a reasonable cost. Additional equipment, which is Obstacle Avoidance (OA) technology, of the drone will be beneficial while approaching a structure to prevent damage to both structure and drone components. Another key consideration is the ability to fly without GPS signal. This enables the drone to inspect underneath bridges without the problem of losing satellite connection, as stated before. Some attachments including a flashlight and second camera could be added to the drone to overcome such inspection challenges.

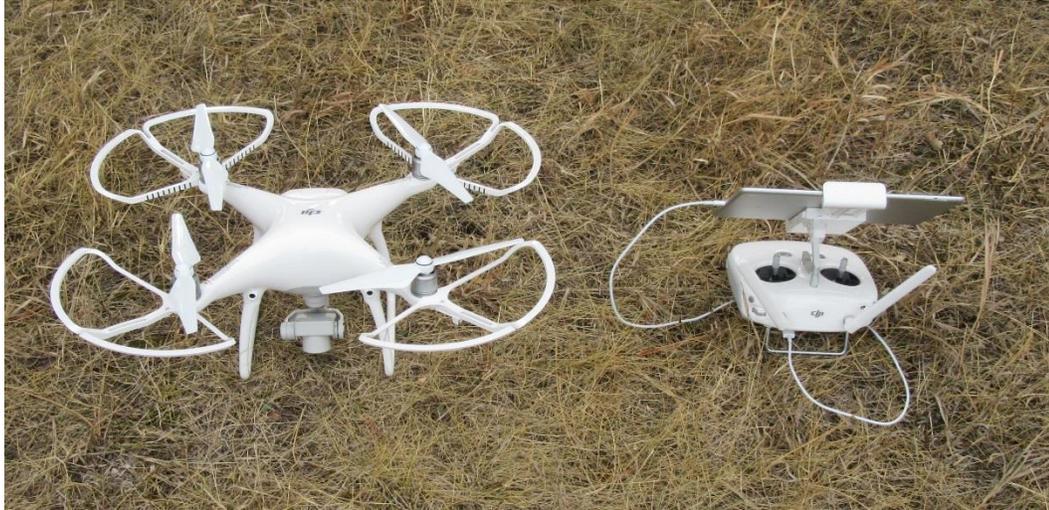
**Fig. 2-1.** Image of the DJI Phantom 4 (taken by Junwon Seo).

Considering the aforementioned specifications, a total of four drones were deemed suitable for bridge inspection. The selected drones include the DJI Matrice 100, DJI S900, DJI Phantom 3 pro, and DJI Phantom 4. Among the suitable drones, the DJI Phantom 4 (see **Fig. 2-1**) was selected over the others due to its performance and versatility meeting the considered requirements at a reasonable cost. The intent of selecting an affordable drone was to provide a viable and cost-efficient alternative to current inspection practices that can be implemented by county-level administrations. Additional technology, which is Obstacle Avoidance (OA), allows the drone to avoid harm to both bridge and drone components along with persons and property. Another consideration is the ability to fly in manual mode to avoid Global Positioning System (GPS) signal under the bridge, as mentioned in the past literature (Lovelace and Zink 2015). It should be noted that drone technologies have rapidly grown in recent years; thus, their costs and features will be quickly changed over time.

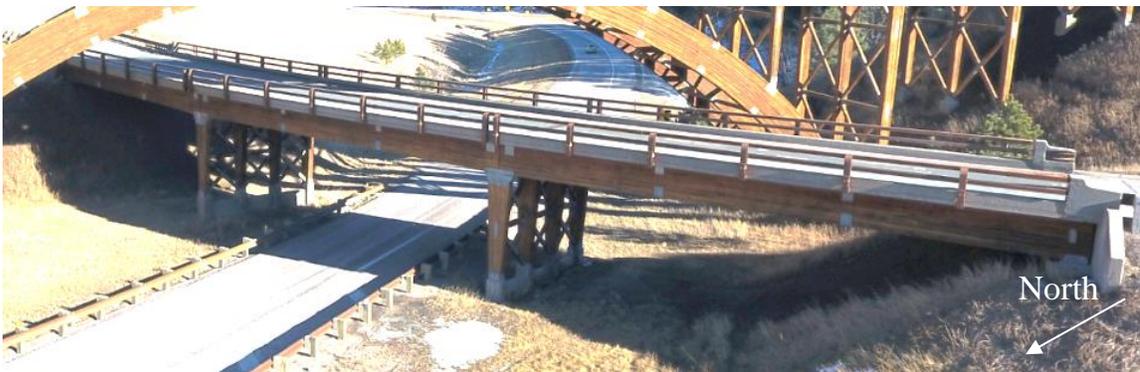
**Fig. 2-2.** Glulam timber girder bridge overview taken by the drone (taken by Luis Duque).

A glued-laminated girder bridge with a composite concrete deck was selected as seen in **Fig. 2-2**. The bridge is located on US16 to US16A Highway, near the city of Keystone in Pennington County, SD. The bridge has three simply supported spans with four girders spaced at 2.3 m (7.5 ft.) on center (o.c.) and a clear width of 7.9 m (26 ft.). The bridge is horizontally curved at an estimated radius of 116.4 m (881.97 ft.) and is a 51.8 m (170 ft.) long with steel guardrails along the edges of the superstructure.

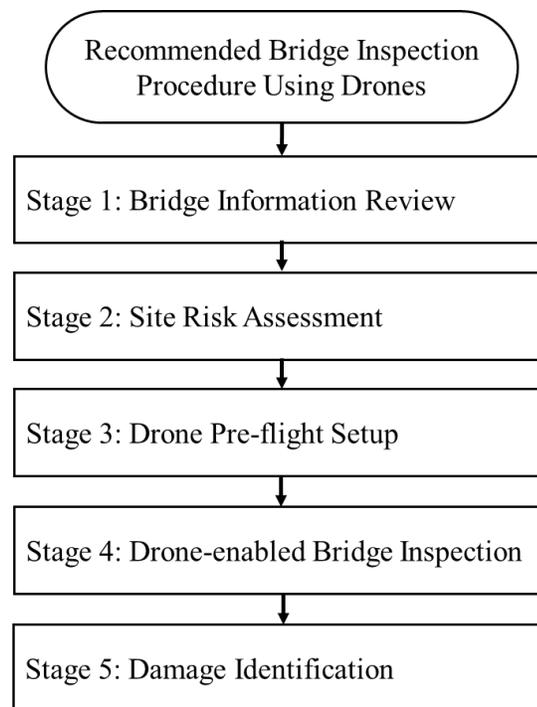
**Fig. 2-3.** Recommended five-stage bridge inspection protocol using a drone.

Due to a lack of systematic damage identification and drone inspection procedures, a five-stage bridge inspection protocol that allowed for an efficient drone-enabled bridge inspection (see **Fig. 2-3**) was developed. The protocol was based on holistic information related to drone limitations, drone operation conditions, and data acquisition methodology. State and federal regulations were also considered. The protocol is detailed below:

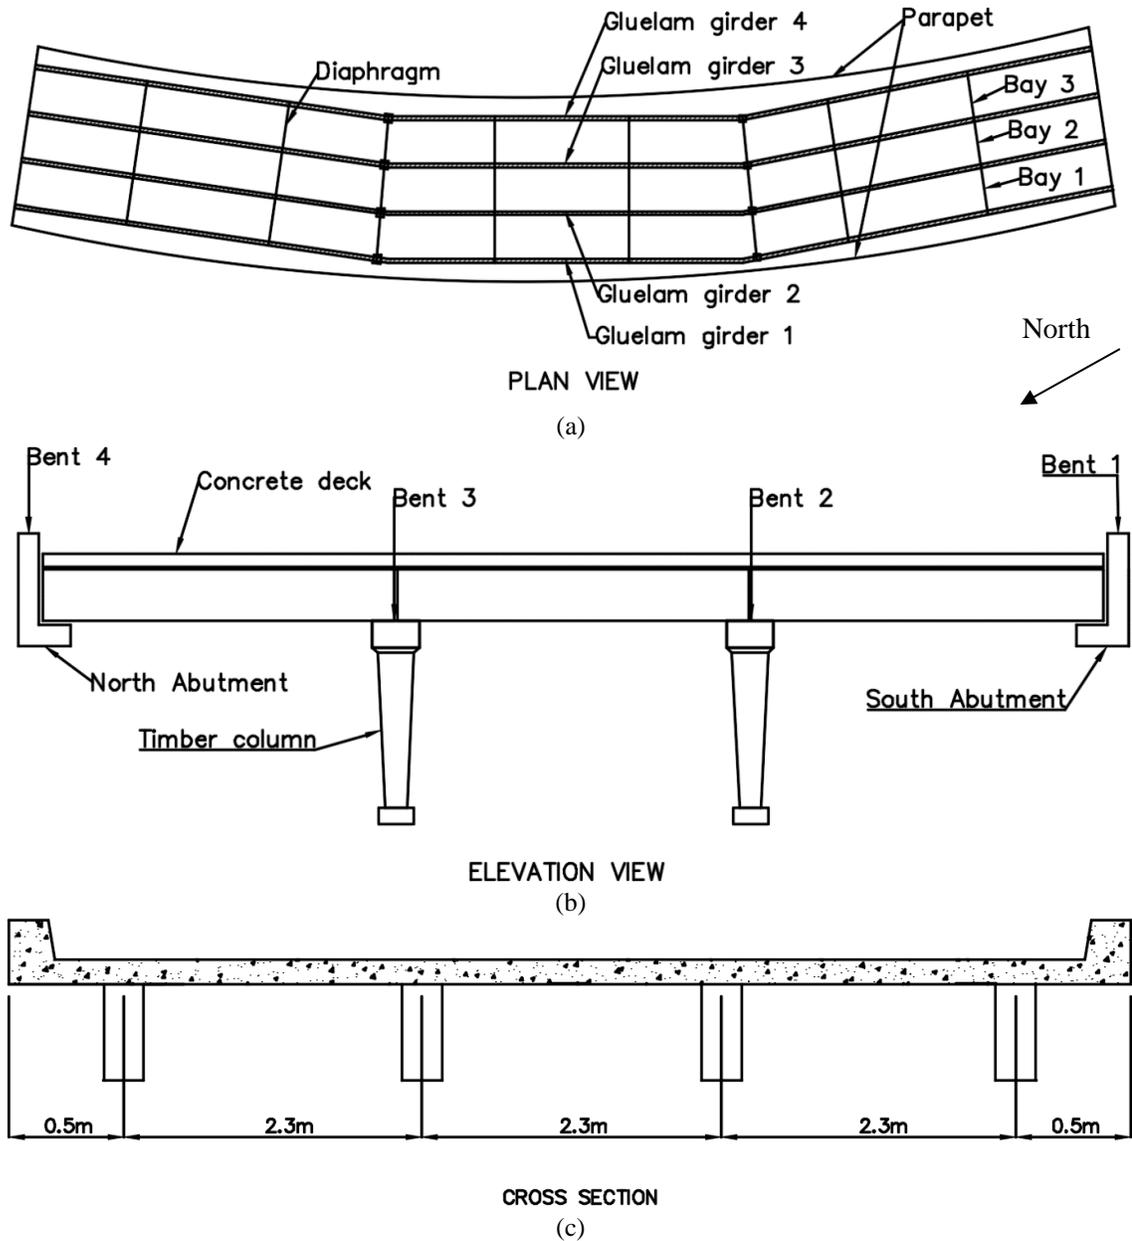
**Fig. 2-4.** Glulam timber girder bridge components numbering: (a) component numbering on plan view; (b) component numbering on elevation view; and (c) cross-section view.

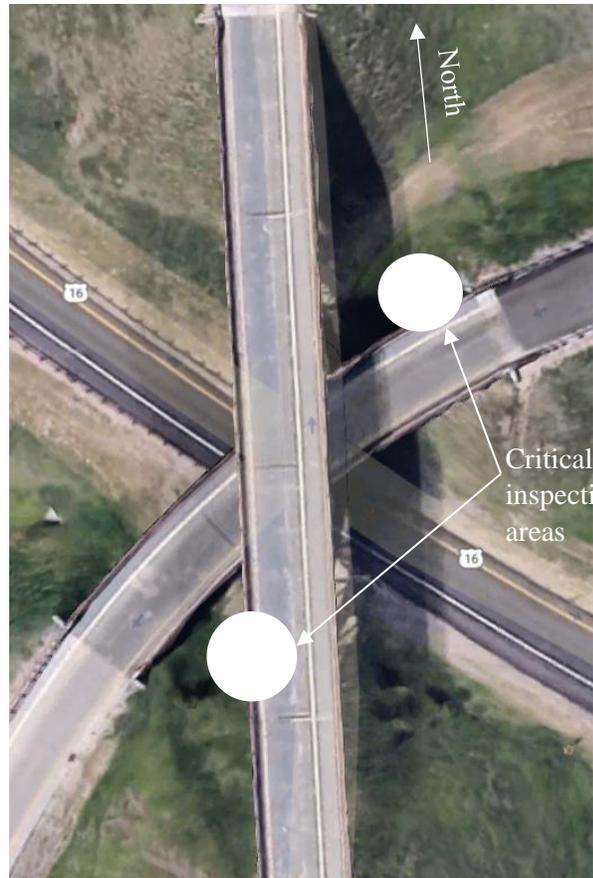
**Fig. 2-5.** Critical bridge inspection areas (extracted from Google Maps).

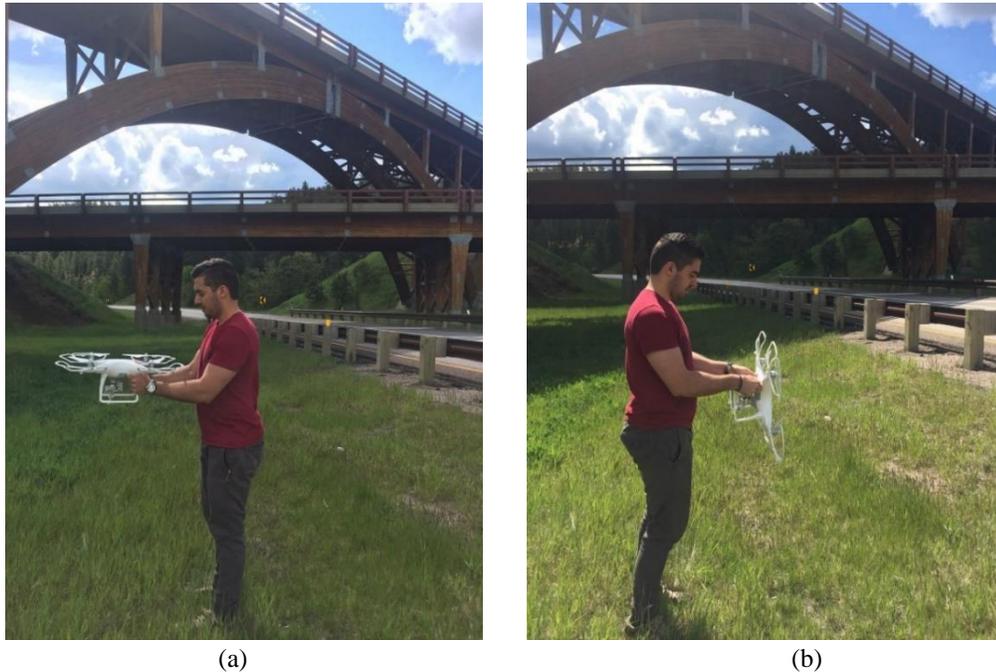
**Fig. 2-6.** DJI Phantom 4 compass calibration demonstration: (a) drone camera horizontally rotating counterclockwise and (b) drone camera facing down rotating counterclockwise (taken by Callie Duque using digital camera).

horizontally shown in **Fig. 2-6a**. Then, the same rotation is executed with the drone vertically and the camera facing down as seen in **Fig. 2-6b**.

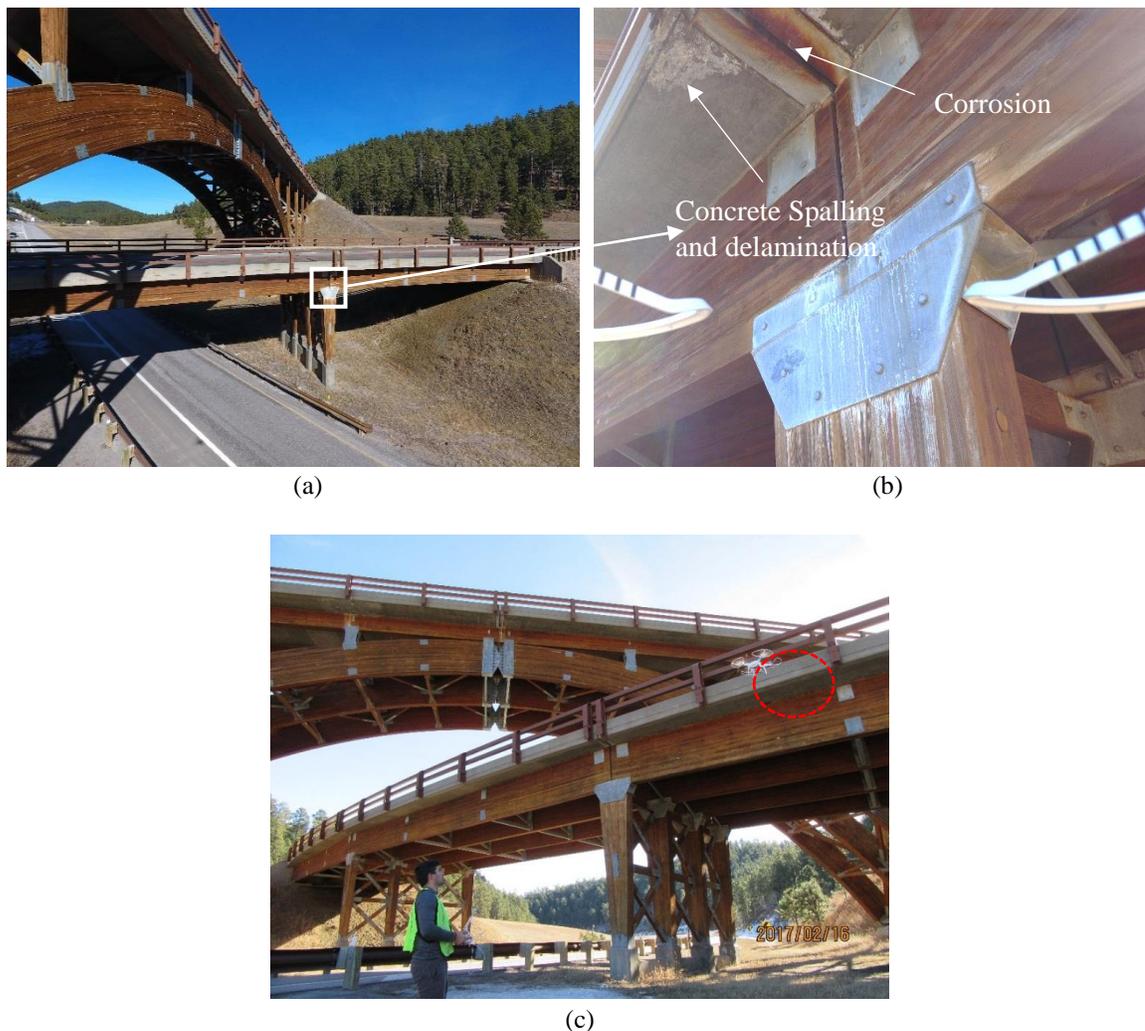
**Fig. 2-7.** Sample images obtained from the timber girder bridge inspection: (a) glulam girder bridge overview (taken by Junwon Seo using drone); (b) damage on timber girder bridge (taken by Luis Duque using drone); and (c) drone flying near girder (taken by Junwon Seo using digital camera).

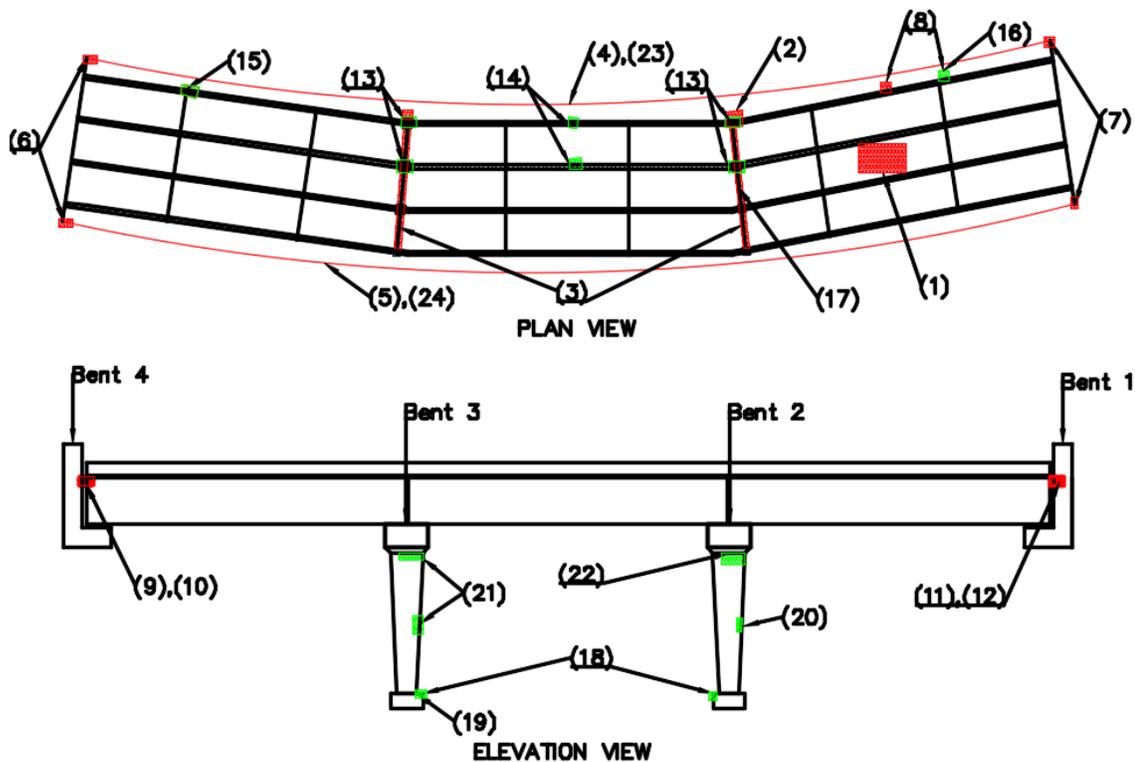
*Note: red marks in plan and elevation views indicate concrete damage, green marks represent timber damage. Also, red lines in plan view denote minor cracks along the parapet and rusting in railing in a longitudinal direction.*

The final stage for the drone-enabled bridge inspection is to conduct the *Damage Identification*. Sample results for the Underside of Deck, Abutment, and Girder damage are presented to demonstrate the quality of data obtained using the drone. Using a photogrammetric computer software, PhotoScan, the structural components were recreated in 3D virtual space to observe the damage from different angles. The schematic shown in **Fig. 2-8**, shows all the identified damage on the bridge using the drone.

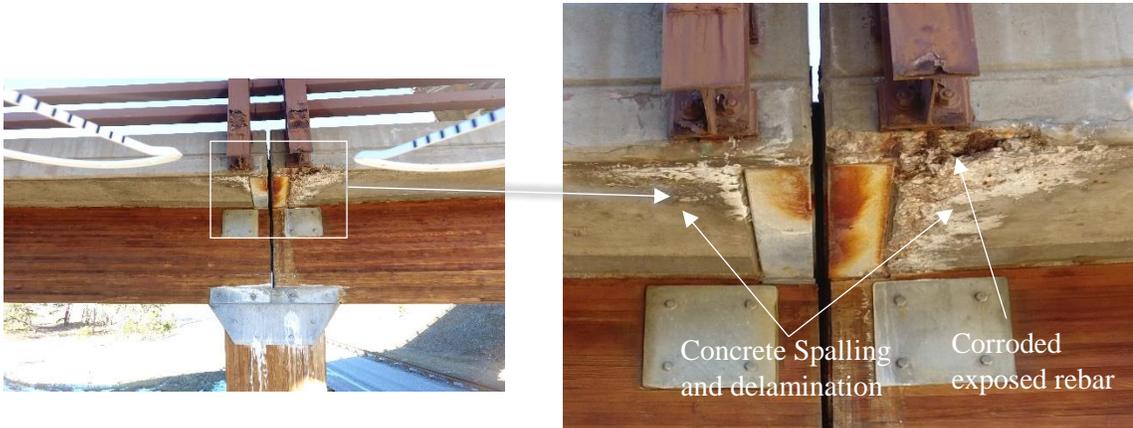
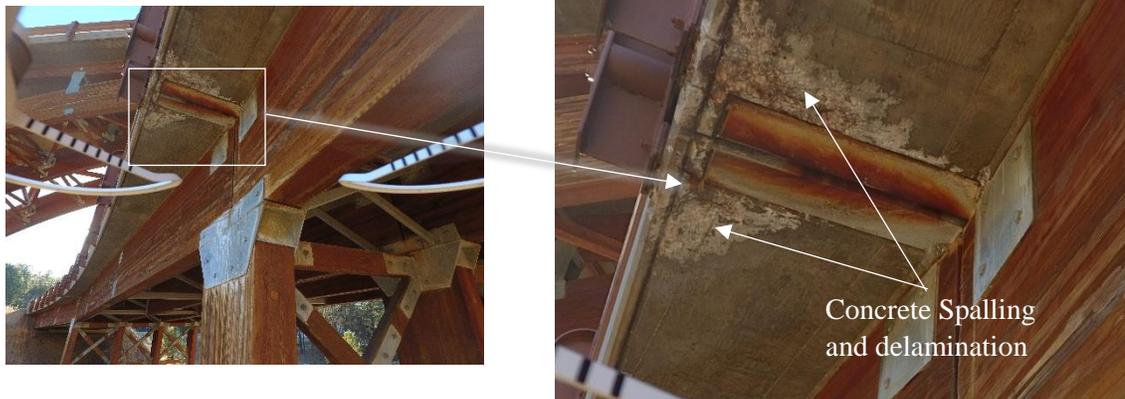
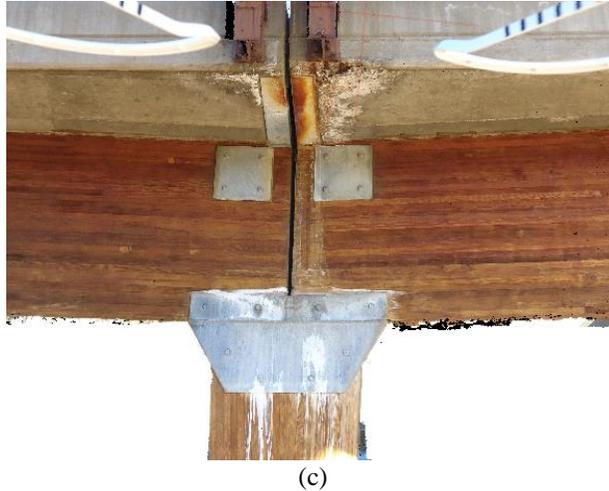
**Fig. 2-9.** Underside of deck sample damage gathered using drone (taken by Junwon Seo): (a) concrete spalling and corrosion with exposed rebar near Girder 4 at Joint 1; (b) concrete spalling near Girder 4 at Joint 3; and (c) 3D virtual model of Joint 2 near Girder 4 using PhotoScan.

**2-9a** shows concrete spalling and exposed rebar near Girder 4 at Joint 2 and **Fig. 2-9b** presents concrete spalling and delaminations near Girder 4 at Joint 3. Further, a representation of the damage near Girder 4 at Joint 2 was created using PhotoScan to create a 3D virtual model in order to better visualize it in 3D virtual space as seen in **Fig. 2-9c**.

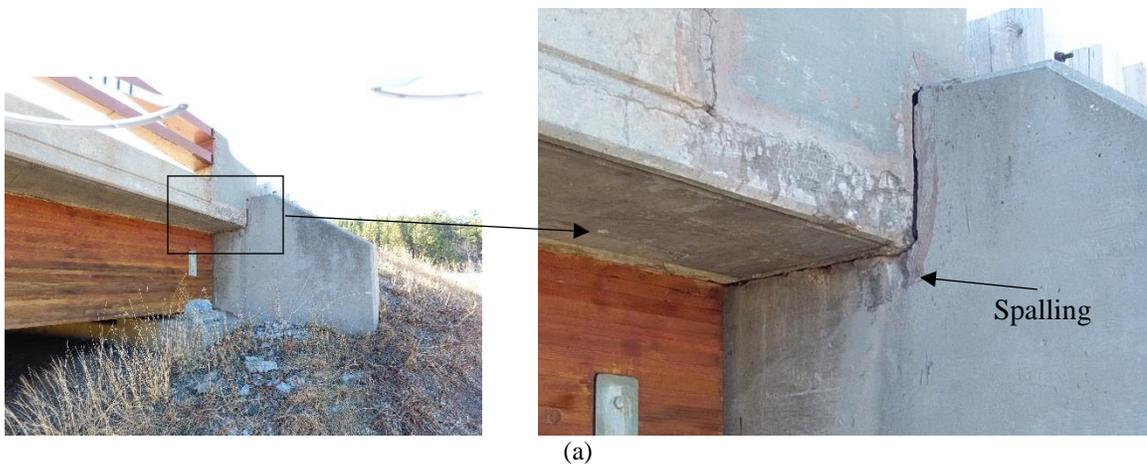
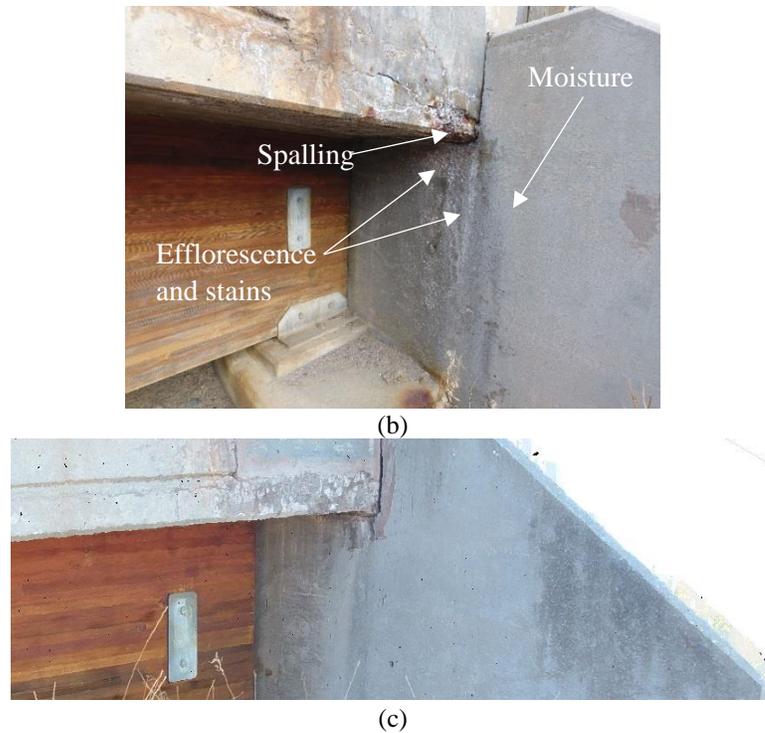
**Fig. 2-10.** Sample abutment damage detected using drone (taken by Luis Duque): (a) Spalling on South Abutment near Girder 1; (b) spalling and discoloration of concrete caused by moisture at North Abutment near Girder 4; and (c) 3D virtual representation of South Abutment near Girder 1.

The abutments were identified as being in overall good condition. Only minor damage such as cracking and discoloration was observed during the drone-enabled inspection as seen in **Fig. 2-10a** and **2-10b**. **Fig. 2-10a** shows spalling on the South Abutment near Girder 1 and **Fig 2-10b** displays spalling, efflorescence, and moisture on the North Abutment near Girder 4. Additionally, using PhotoScan, the damage on the South Abutment near Girder 1 was successfully recreated in 3D virtual space as seen in **Fig. 2-10c**

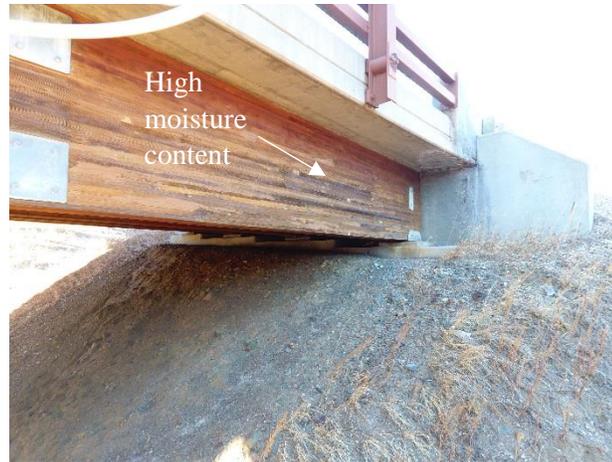
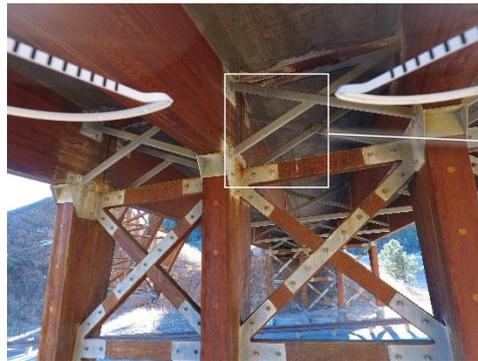
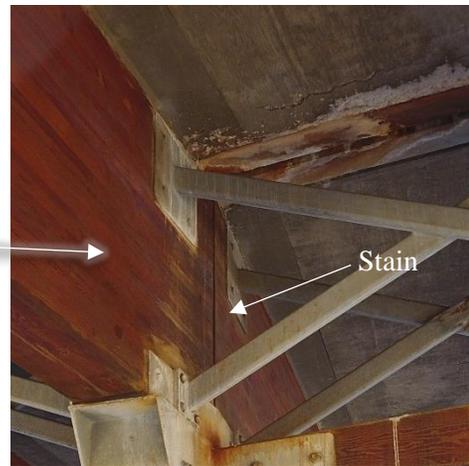
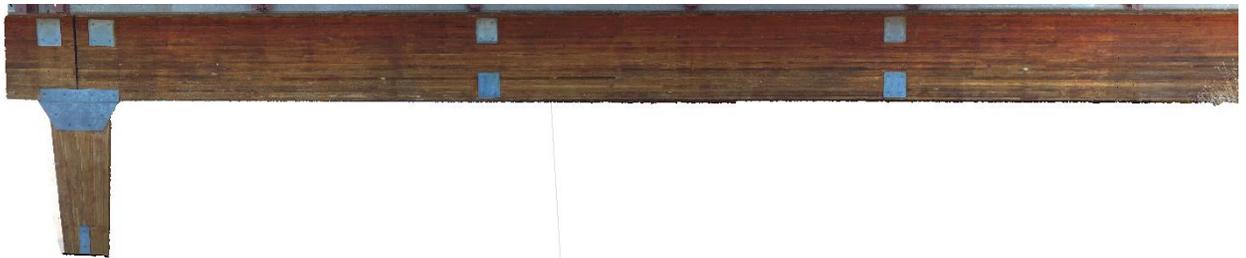
Overall, the girders were in good condition despite some minor water damage caused by water coming from the deck. In detail, the ends of the girders presented some stains and discoloration possibly caused by calcium deposits from the chemical reaction between salt, water, concrete, and steel, especially during the winter season. Sample images of the sample identified damage can be seen in **Fig. 2-11a** and **2-12b**. **Fig. 2-11a** shows high moisture on Girder 4 between Joints 3 and 4 and **Fig. 2-11b** illustrates stains due to water leakage from the deck. With the aid of PhotoScan, the Girder 4 between Joints 3 and 4 was successfully recreated in 3D virtual environment.

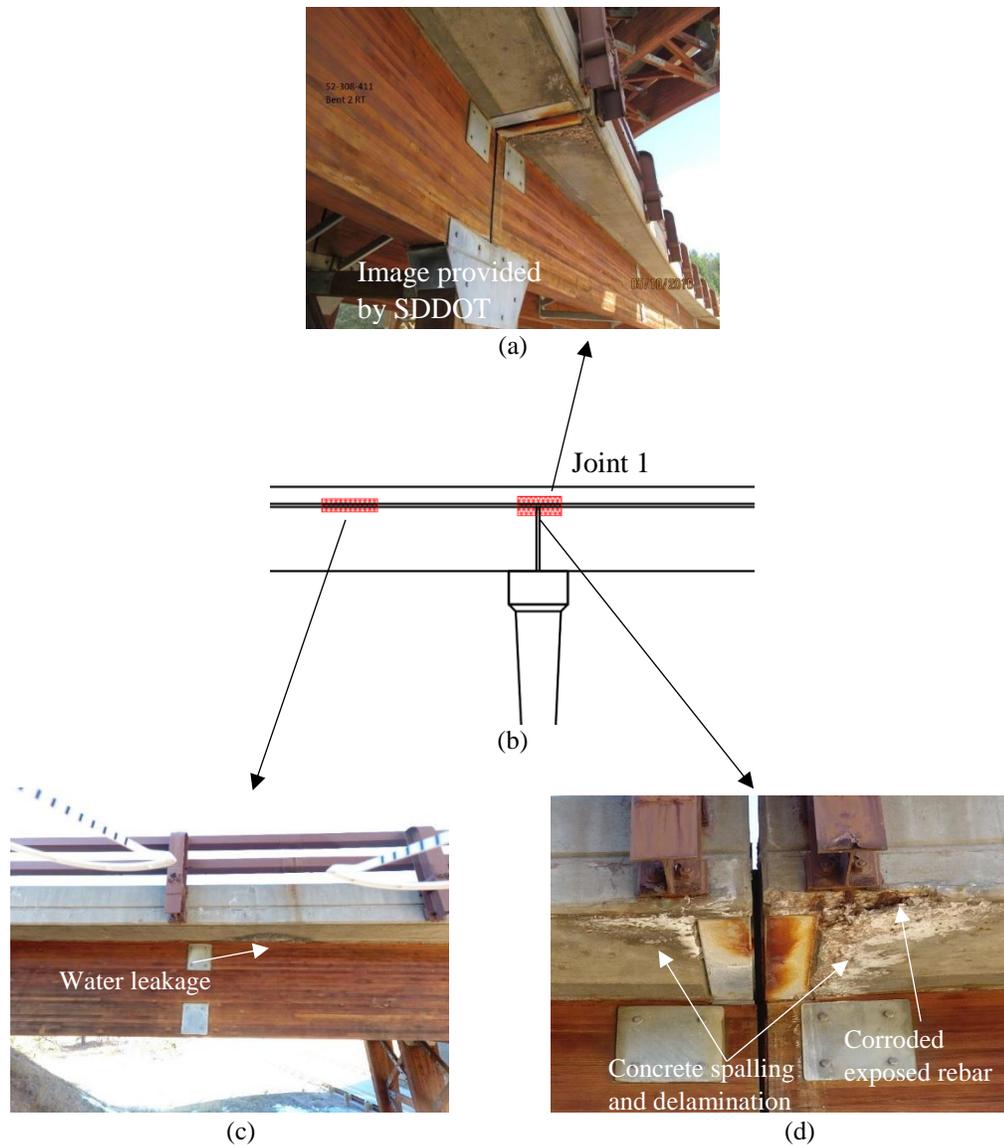
**Fig. 2-12.** Comparison of results between drone-enabled and conventional inspections: (a) image provided by SDDOT; (b) damage locations; (c) water leakage under deck between South Abutment and Joint 1 (taken by Luis Duque using drone); and (d) concrete spalling and corrosion with exposed rebar near Girder 4 at Joint 1 (taken by Luis Duque using drone).

The inspection report developed based on the drone-enabled bridge inspection findings coincided with the damage reported by the SDDOT. As expected, damage such as concrete spalling, corrosion, and exposed rebar was observed near joints due to water leakage from the surface of the deck. A visual comparison of images provided by the SDDOT to those gathered using the drone can be seen in **Fig. 2-12**. The image provided by the SDDOT is shown in **Fig. 2-12a** to provide a visual comparison to those taken using the drone as seen in **Fig. 2-12c** and **Fig. 2-12d**. It is evident that the images are of similar quality, and for the underside of deck, the drone was able to capture a closer view.

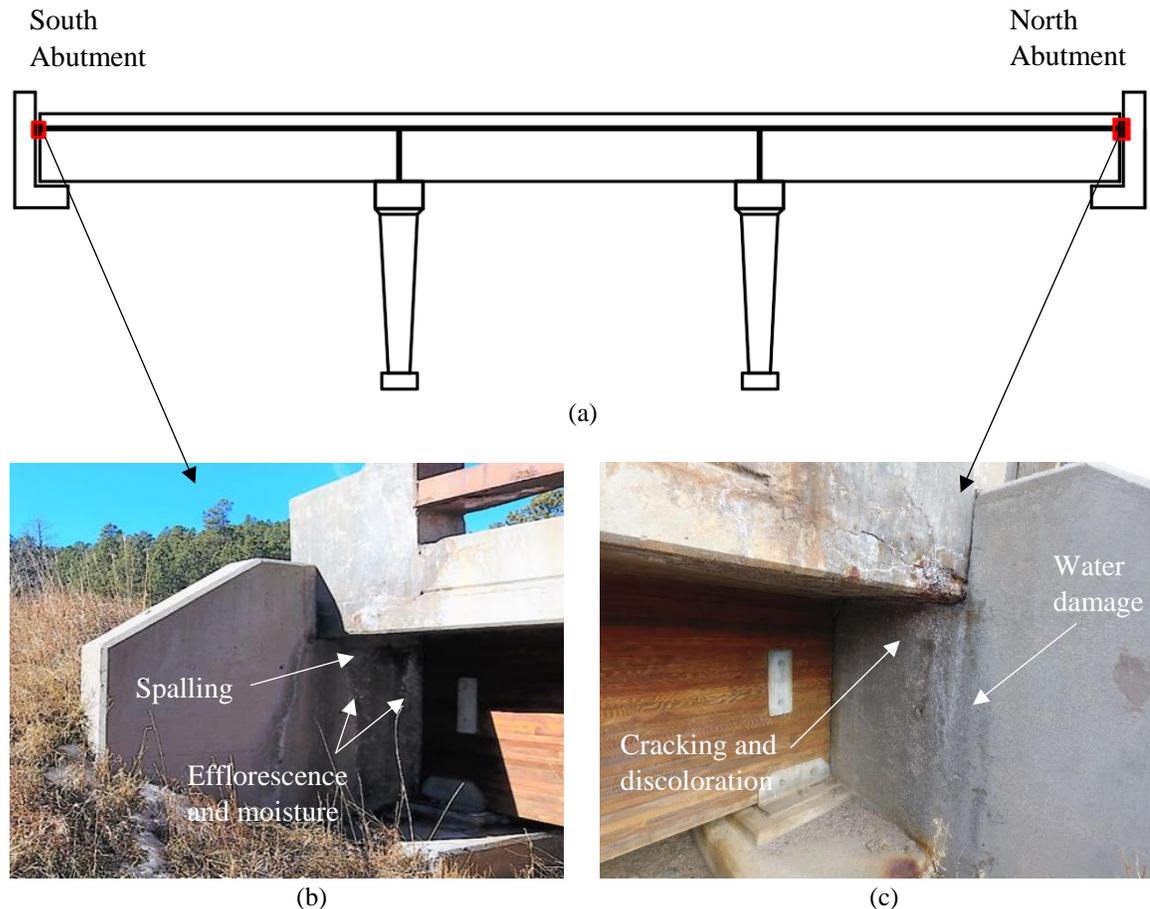
**Fig. 2-13.** Sample damage on Abutment: (a) schematic of damage location on abutment; (b) damage on South Abutment near Girder 4 (taken by Luis Duque using drone); and (c) damage on North Abutment near Girder 4 (taken by Junwon Seo using drone).

Abutment (see **Fig. 2-13c**). It can be noted that there were no images provided by the SDDOT to be compared for the abutments.

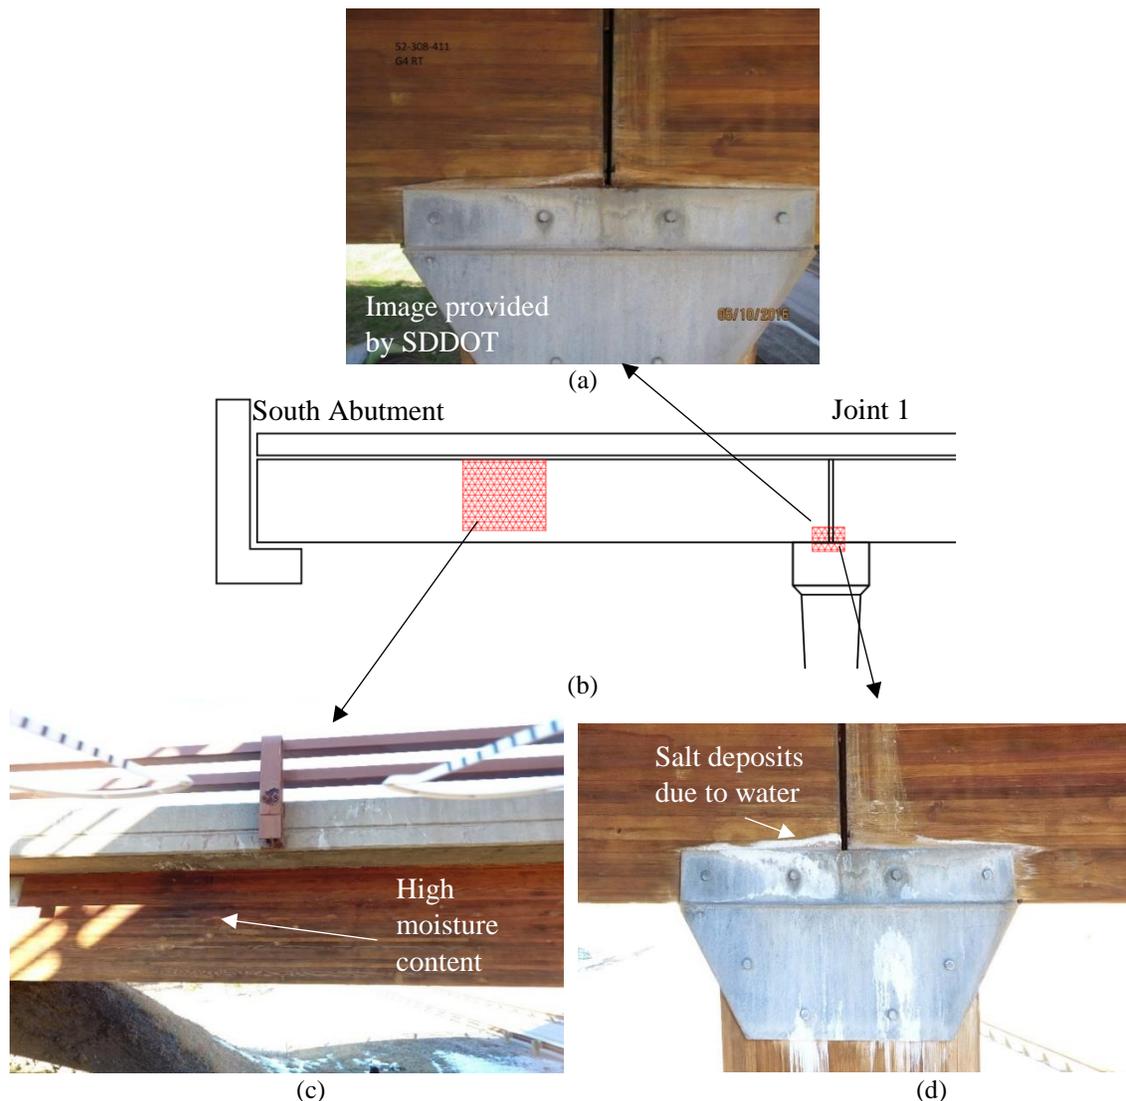
**Fig. 2-14.** Comparison of identified damage on girder: (a) image provided by SDDOT; (b) damage location; (c) damage on Girder 4 between South Abutment and Joint 1 (taken by Junwon Seo using drone); and (d) salt deposits due to water coming from deck at support of Girder 4 at Joint 1 (taken by Junwon Seo using drone).

obtain high-quality data for damage identification. Note that some damage, such as moisture on Girder 4 between Joints 1 and 2 and Girder 4 between Joints 3 and 4, were not specified by the SDDOT. This damage must have been recent and demonstrated the importance of frequent routine inspections using drones to evaluate the damage and prevent unreparable structure failure.

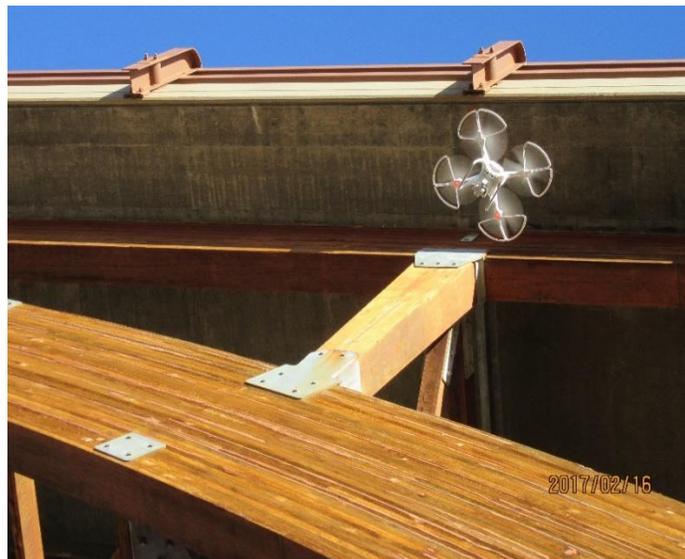
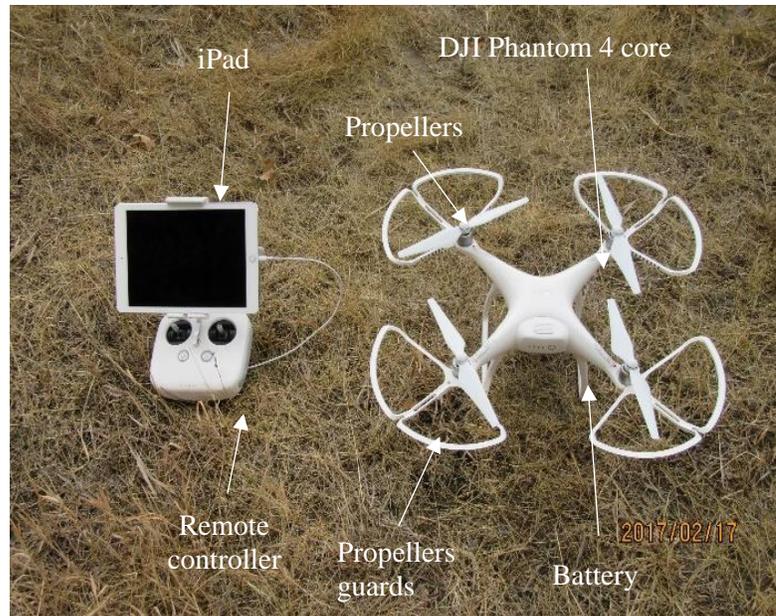
**Fig. 3-1.** DJI Phantom 4: (a) UAV flying near a bridge and (b) UAV set up prior to inspection (captured by Junwon Seo using digital camera).

For the selection of the UAV, a comprehensive comparison between thirteen different UAVs from seven different manufacturers was conducted. When selecting the appropriate UAV for the damage quantification, different considerations, including flight time, camera location, image resolution, video resolution, payload capacity, UAV lights, and remote range, were considered. Considering these specifications and analyzing the advantages and disadvantages for each UAV, a Dà-Jiāng Innovations (DJI) Phantom 4 was selected (see **Figs. 3-1a** and **3-1b**). The cost-performance ratio provided a high-end UAV with

appropriate technology suitable for bridge inspection at an affordable price. In particular, the technology of the DJI Phantom 4 includes the ability to avoid obstacles with sensors at the front and the bottom; thus, the UAV pilot can be allowed to fly between complicated sections near the bridge. Other relevant specifications, such as the ability to fly without Global Positioning System (GPS) signal, high-resolution camera, and 135-degree camera vertical rotation, allow the UAV to efficiently inspect a bridge. Details on the selection of UAVs can be found in past work done by Duque et al. (2017).

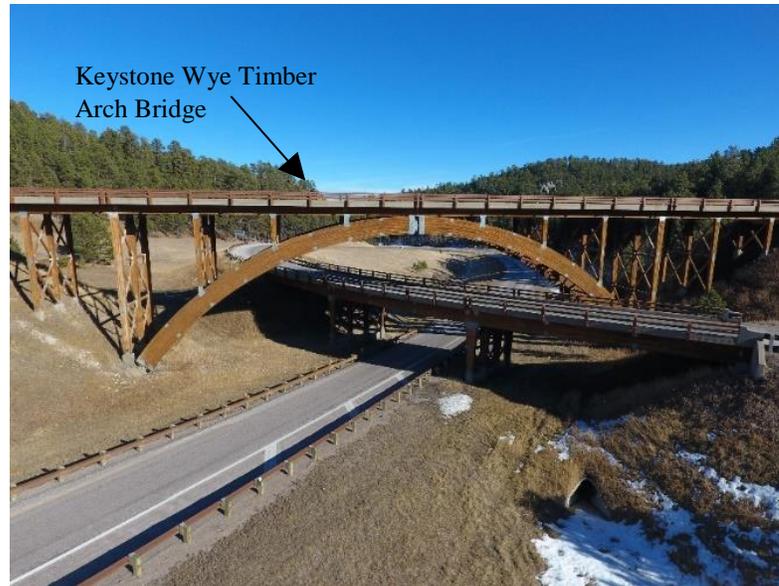
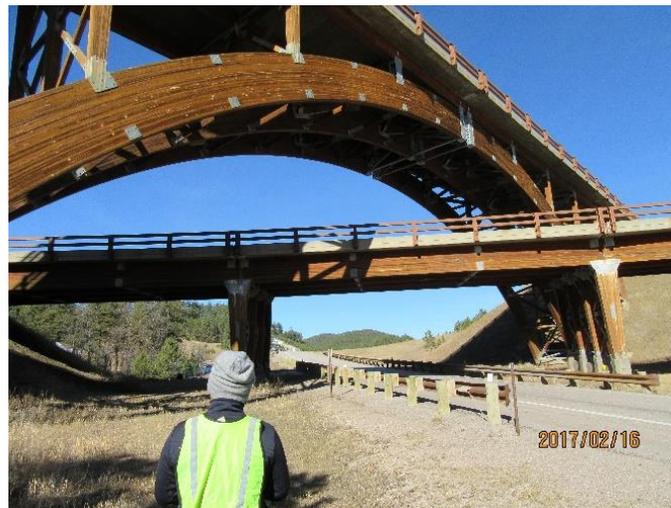
**Fig. 3-2.** Selected Keystone Wye timber arch bridge: (a) overview of bridge (captured by Luis Duque using UAV) and (b) view from under the arch (captured by Luis Duque using digital camera).

A bridge located within the Black Hills National Forest in the state of South Dakota (SD) was selected for the damage quantification study in conjunction with the UAV (see **Figs. 3-2a** and **3-2b**). The selected bridge was the Keystone Wye timber arch bridge, which has three continuous spans with a total length of 19.20 m (63 ft.) near the end approaches, and a symmetrical set of four continuous spans with a length of 24.69 m (81 ft.) over both sides of the arch hinge. Three sets of glued-laminated timber stringers spaced at 3.12 m (10.25 ft.) on center (o.c.) support a reinforced concrete deck having a total width of 7.92 m (26 ft.). The bridge has a 49 m (161 ft.) arch span length, a total length of 88.4 m (290 ft.), and guardrails along the edge of the superstructure.

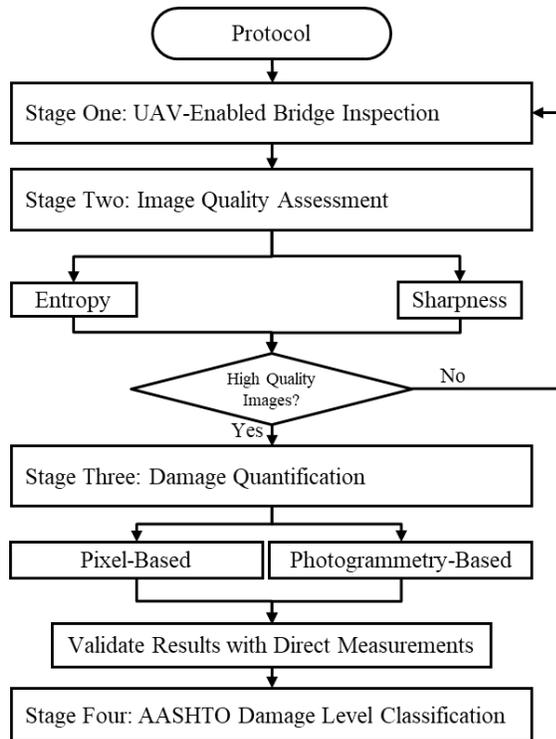
**Fig. 3-3.** UAV-image-based bridge damage quantification protocol.

future generation bridge damage quantification using UAVs. A description of the recommended protocol stages is presented below:

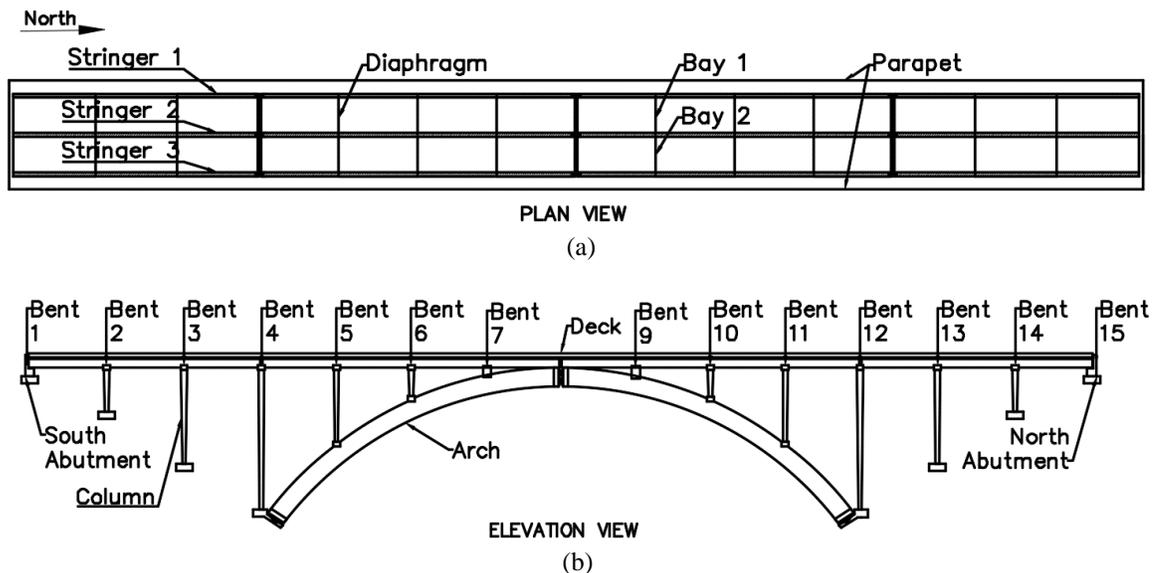
**Fig. 3-4.** Keystone Wye Bridge with structural component numbering: (a) component numbering on plan view and (b) component numbering on elevation view.

To complete an efficient UAV-enabled bridge inspection, the recommended four steps were followed. During the first step, the PIC reviewed the bridge plans and inspection reports provided by the South Dakota DOT (SDDOT). From the bridge plans, the schematic of Keystone Wye Bridge was plotted as seen in **Fig. 3-4**. The component numbering on **Fig. 3-4** was assigned to effectively locate the damage gathered during the UAV-enabled bridge inspection. Moreover, the inspection reports revealed the poor condition of several components including the abutments and deck due to severe cracking and water damage. The information from the inspection reports allowed the PIC to identify critical sections for efficient inspection of the bridge.

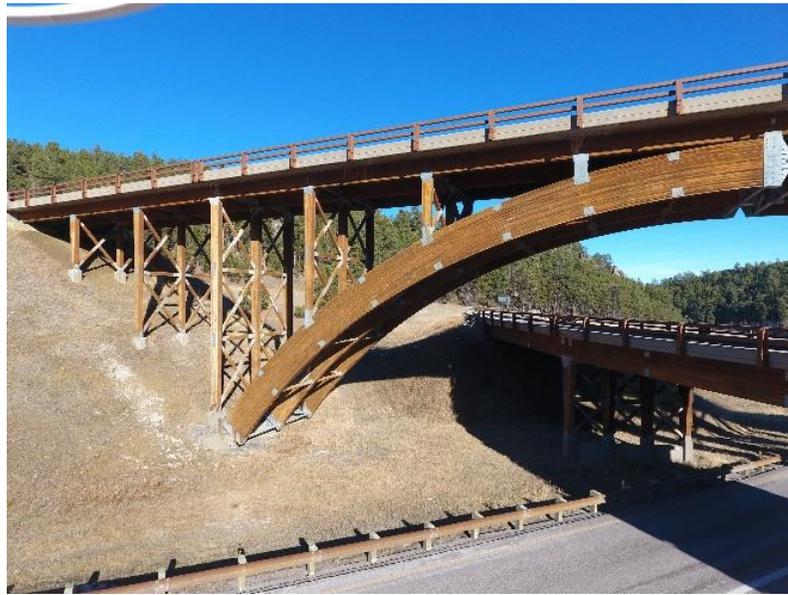
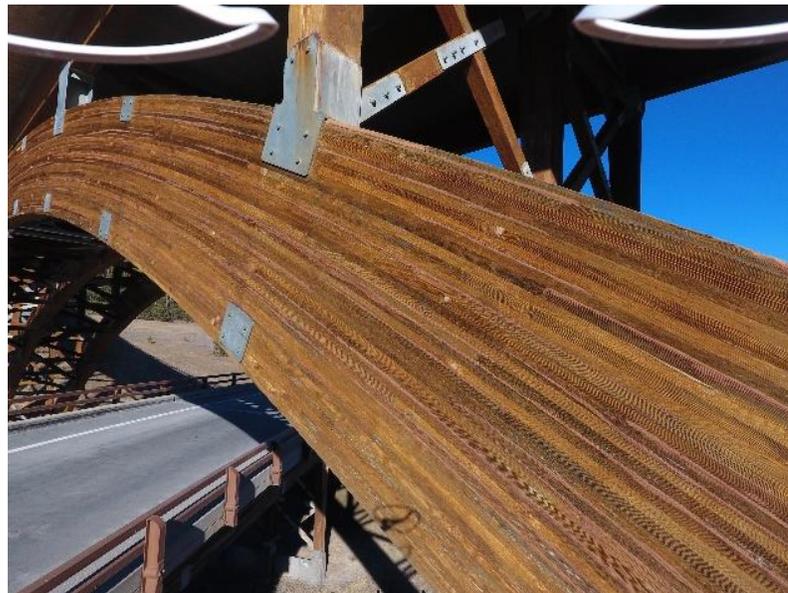
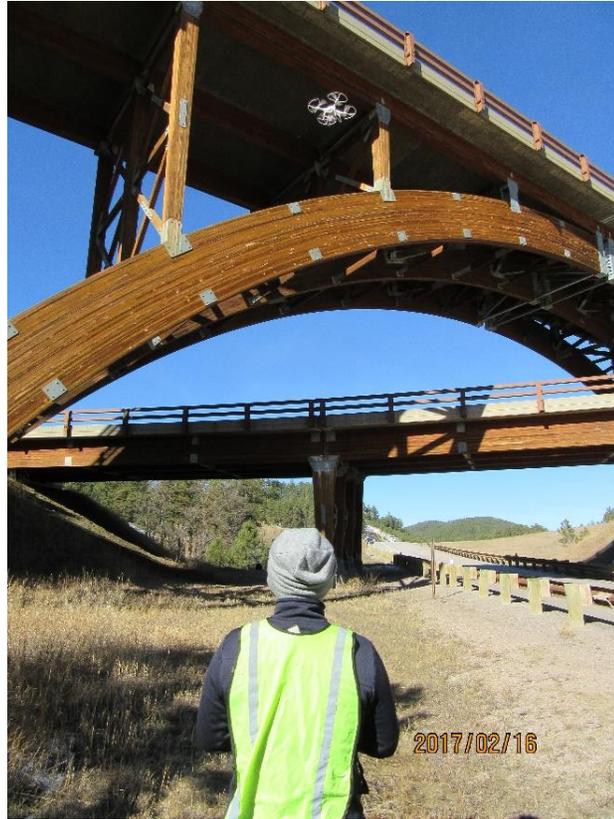
**Fig. 3-5a** shows the elevation view of one half of the bridge and **Fig. 3-5b** shows a detail view of the arch. A sample image of the operation of the UAV can be seen in **Fig. 3-5c**. A complete UAV-enabled bridge inspection procedure can be seen in Seo et al. (2017).

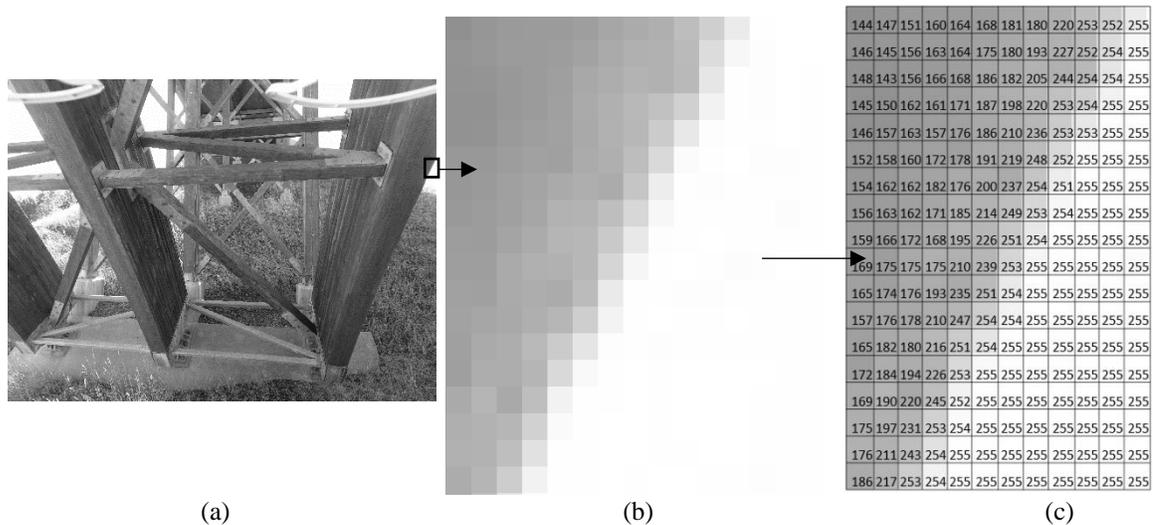
**Fig. 3-6.** Sample pixel values for an image in grayscale: (a) image in grayscale; (b) small portion of image with visible pixels; and (c) grayscale pixel values for small portion of image.

where  $E$  = scalar value of entropy, *Entropy* (MATLAB function to determine entropy);  $I$  = input image in a grayscale; and  $p$  = normalized histogram pixel values for grayscale images. A sample image in a grayscale is presented in **Fig. 3-6** with sample grayscale pixel values for a small portion of the image as a visual representation of the input for the entropy function. **Fig. 3-6a** shows a sample image in a grayscale. **Fig. 3-6b** shows a small portion of the image with visible pixels and **Fig. 3-6c** shows grayscale pixel values corresponding to each pixel within the image.
