## UAV-Based Bridge Inspection and Computational Simulations

UAV– BASED BRIDGE INSPECTION AND COMPUTATIONAL SIMULATIONS

A thesis submitted in partial fulfillment of the requirements for

Major in Civil Engineering

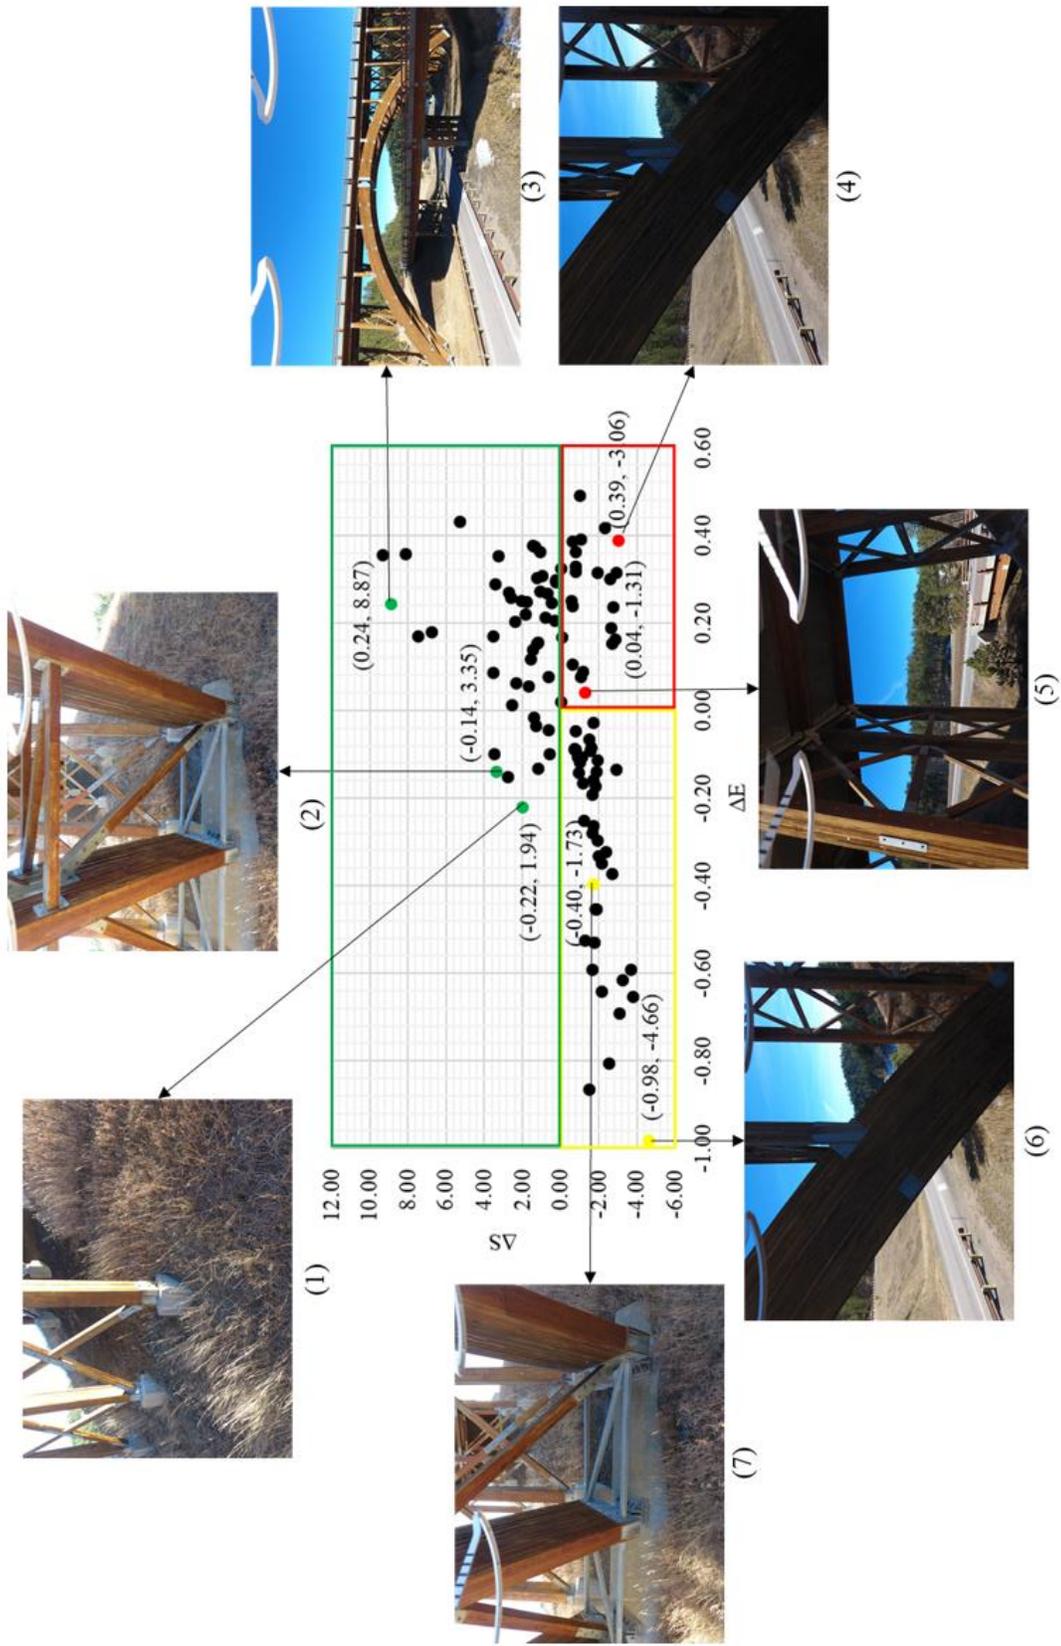
Fig. 3-7. Graphical representation of entropy-sharpness relationship results with sample images.

comparison of images number five and six demonstrated the need to review the images that fall within the yellow area. Following this method, a total of 29 images were considered low-quality images not suitable for damage identification; therefore, they were removed prior to the damage quantification process. It was concluded that the image set presented sufficient number of high-quality images to conduct the damage quantification in Stage Three.

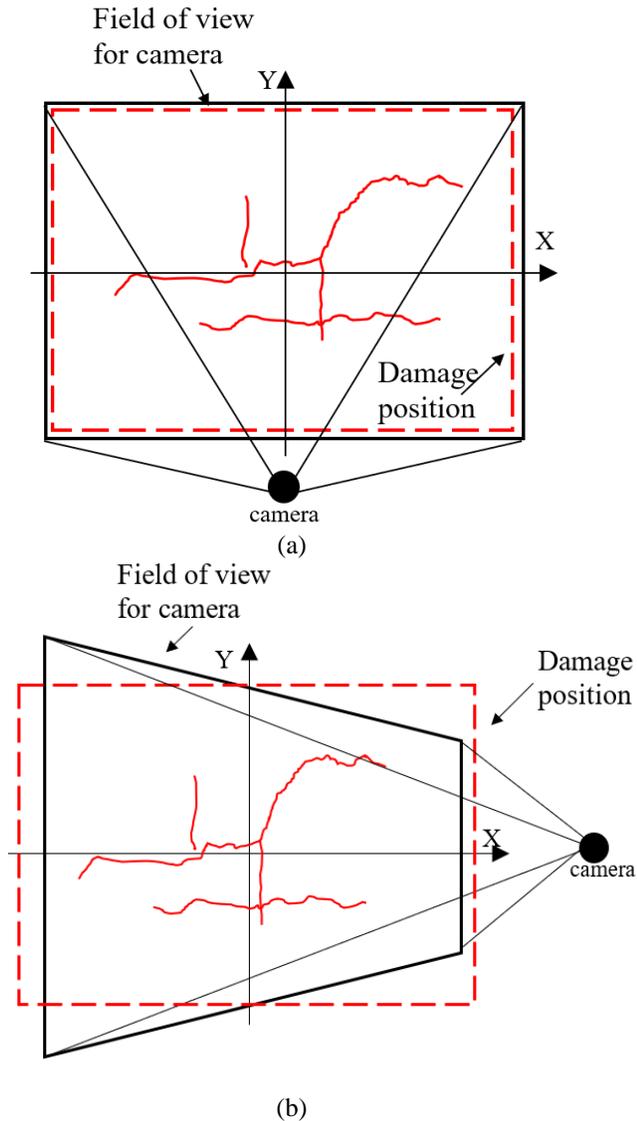
**Fig. 3-8.** Image comparison for different camera position: (a) camera aligned to damage and (b) camera to the side of damage.

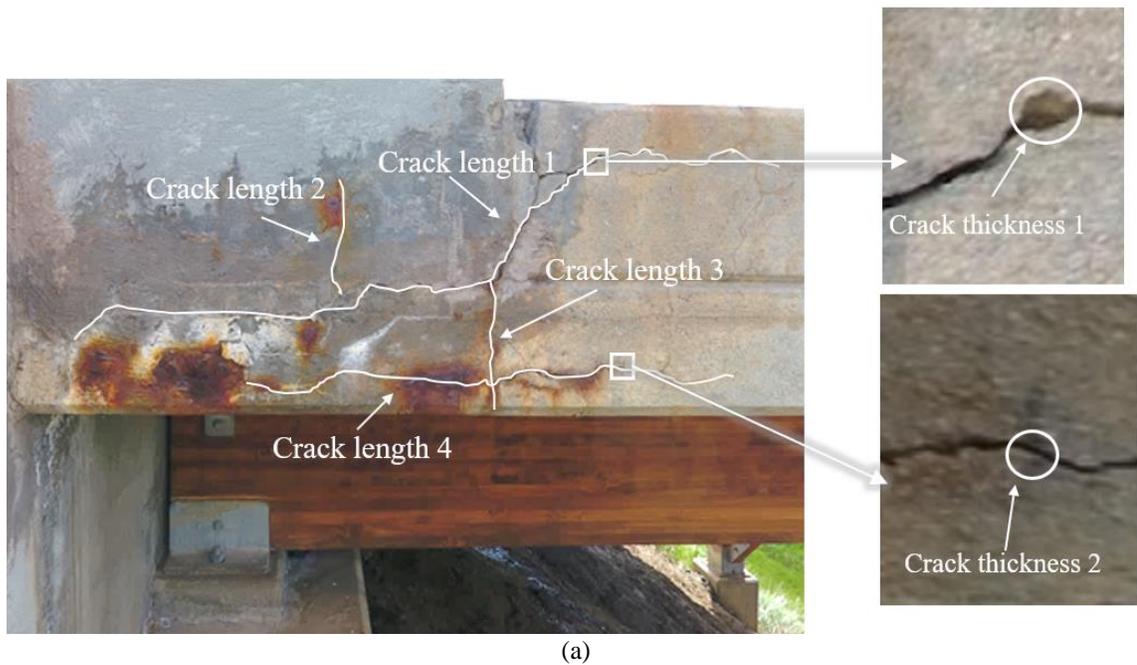
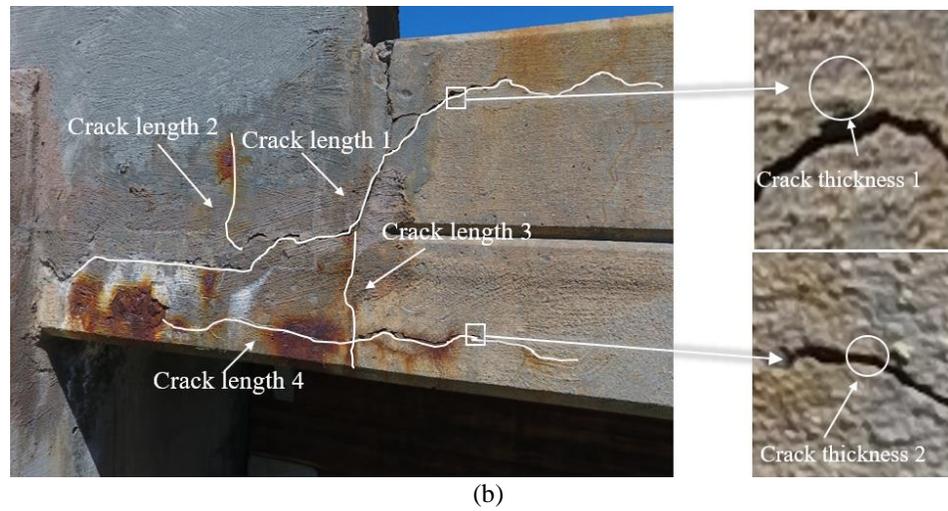
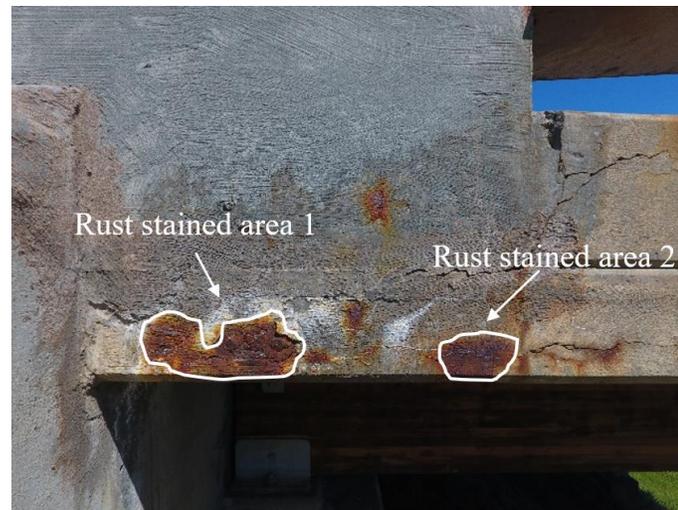
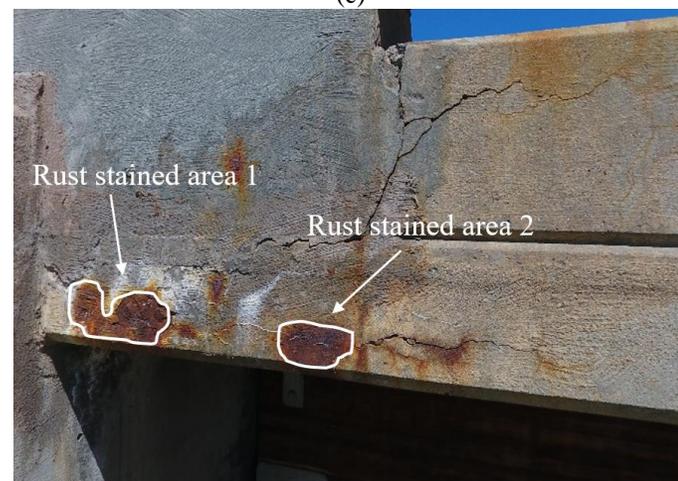
**Fig. 3-9.** Pixel-based damage quantification of damage near abutment of the Keystone Wye Bridge: (a) image aligned with damage; (b) image to the side of damage; (c) identified rust stained areas for image aligned to damage; and (d) identified rust stained areas for the image to the side of damage.

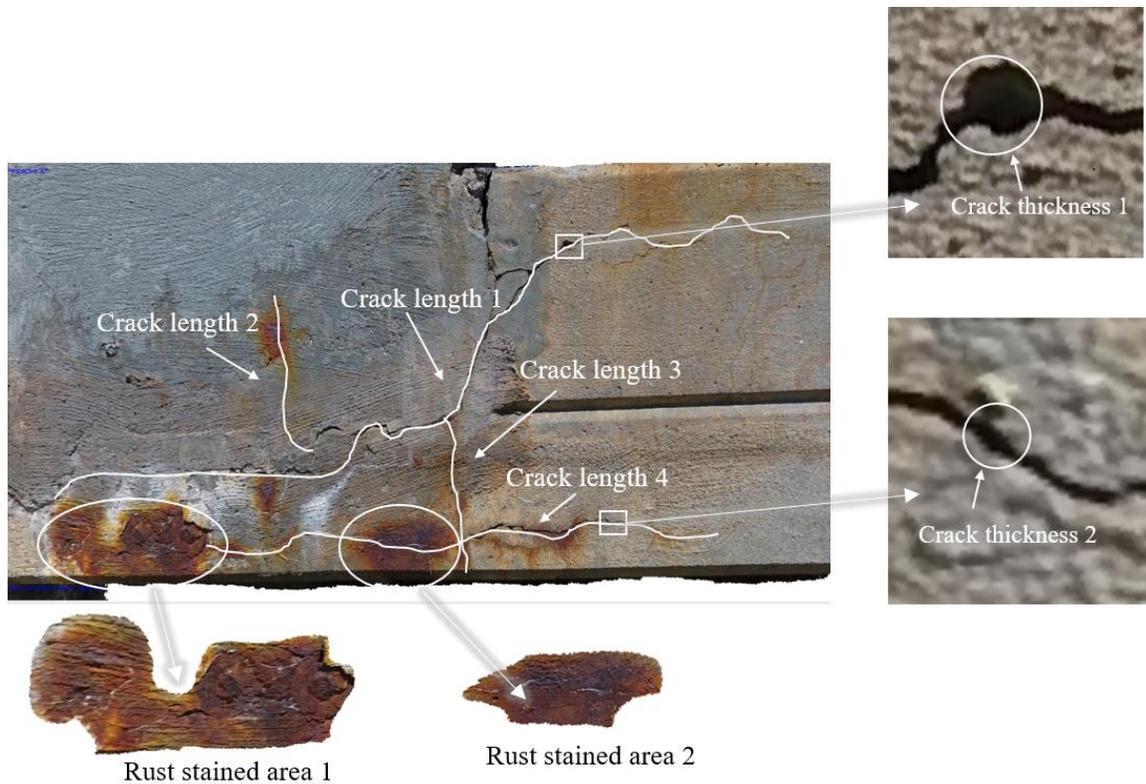
**Fig. 3-10.** Photogrammetry-based 3D virtual model for damage quantification of damage near abutment of Keystone Wye Bridge.

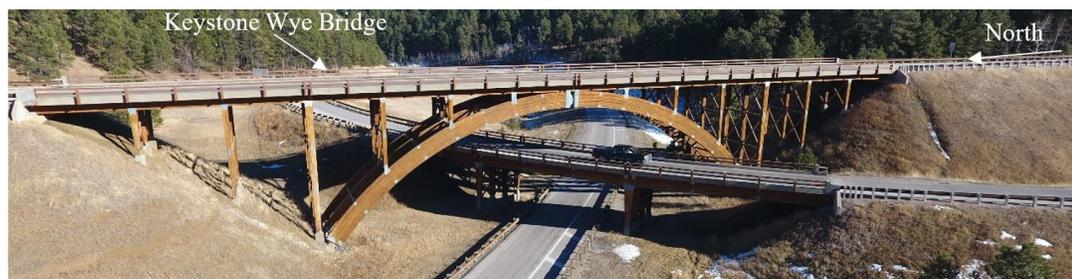
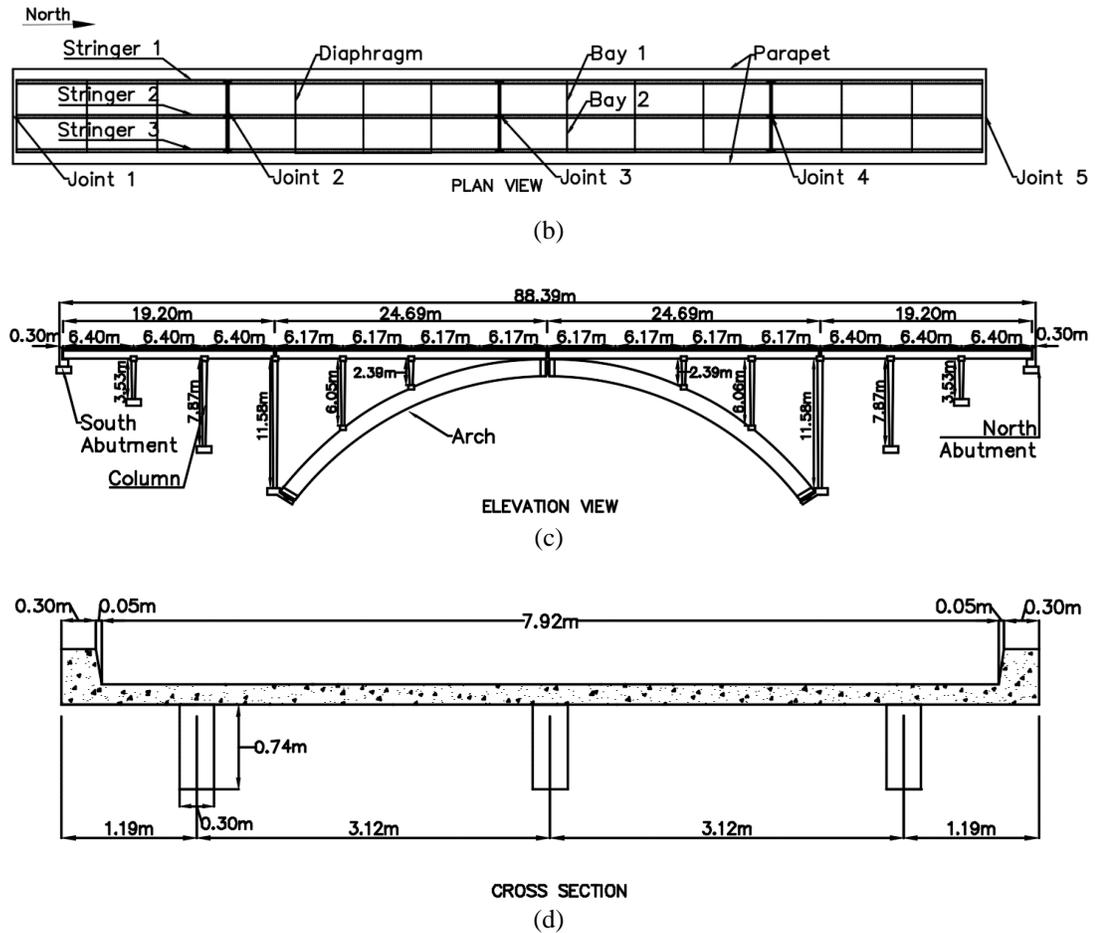
**Fig. 4-1.** Keystone Wye glue-lam arch bridge drawings: (a) overview image of bridge; (b) plan view; (c) elevation view; and (d) superstructure cross section.

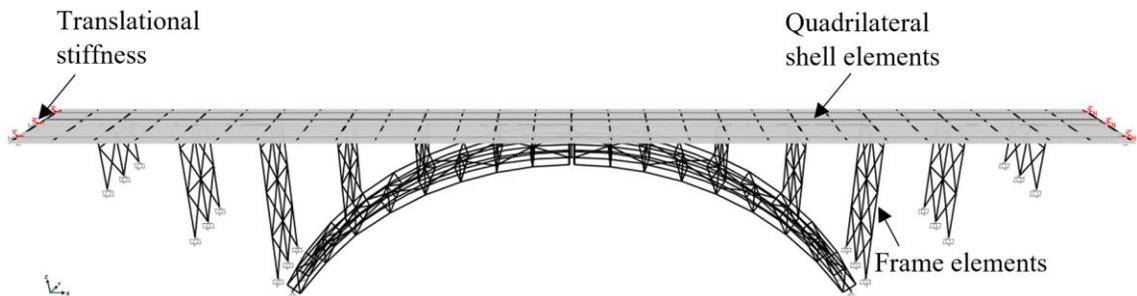
**Fig. 4-2.** SAP2000 3D bridge model schematic.

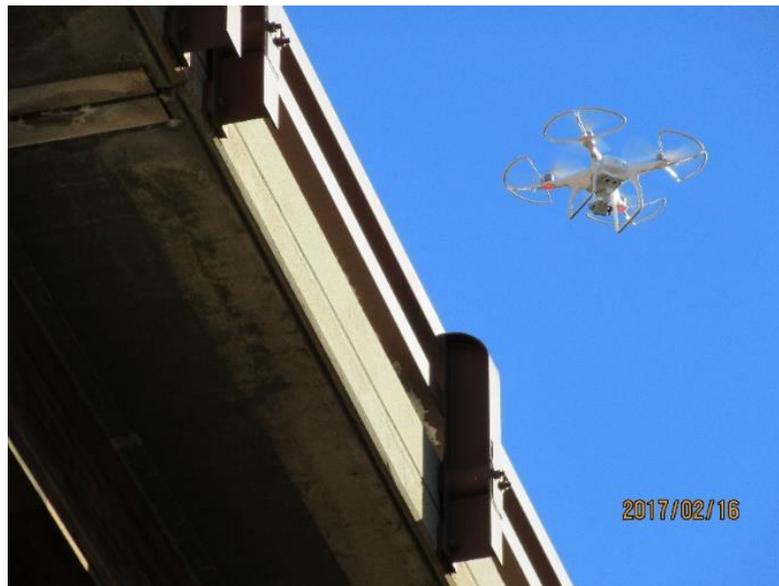
**Fig. 4-3.** Selected DJI Phantom 4 UAV flying near the Keystone Wye Bridge (image captured by Junwon Seo).

3 Pro; (5) DJI Phantom 4; (6) Yuneec Typhoon H; (7) DJI S900 airframe; (8) Yuneec Typhoon 4K; (9) Blade Chroma; (10) Autel Robotics X-Star Premium; (11) SenseFly eBee; (12) SenseFly Albris; and (13) Topcon Sirius Pro. For efficient selection of the suitable UAV for the bridge inspection, seven considerations involving fly time, camera location, camera low light capabilities, video resolution, payload capacity, drone lights, remote range were verified. The DJI Phantom 4 (see **Fig. 4-3**) was the best choice over the other considered UAVs due to higher values of the considerations. Additionally, the DJI Phantom 4 contains the ability to fly without GPS signal and incorporation of the Obstacle Avoidance (OA) technology. This ability allows the UAV to fly under the bridge and near structural components without the risk of accident. A comprehensive list of UAVs considered, and selection process can be found in Duque et al. (2017a).

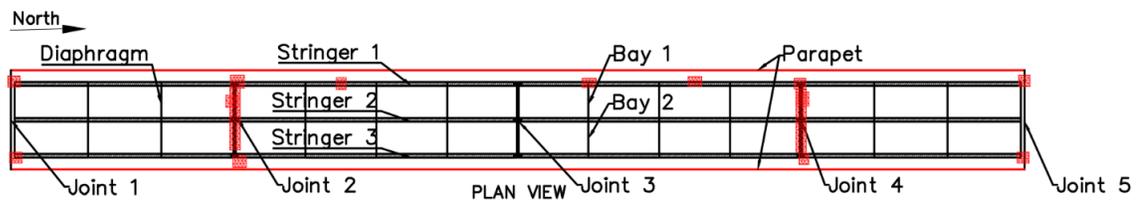
*Note: red marks and lines in plan view indicate damage and minor cracks along the parapet in a longitudinal direction, respectively.*

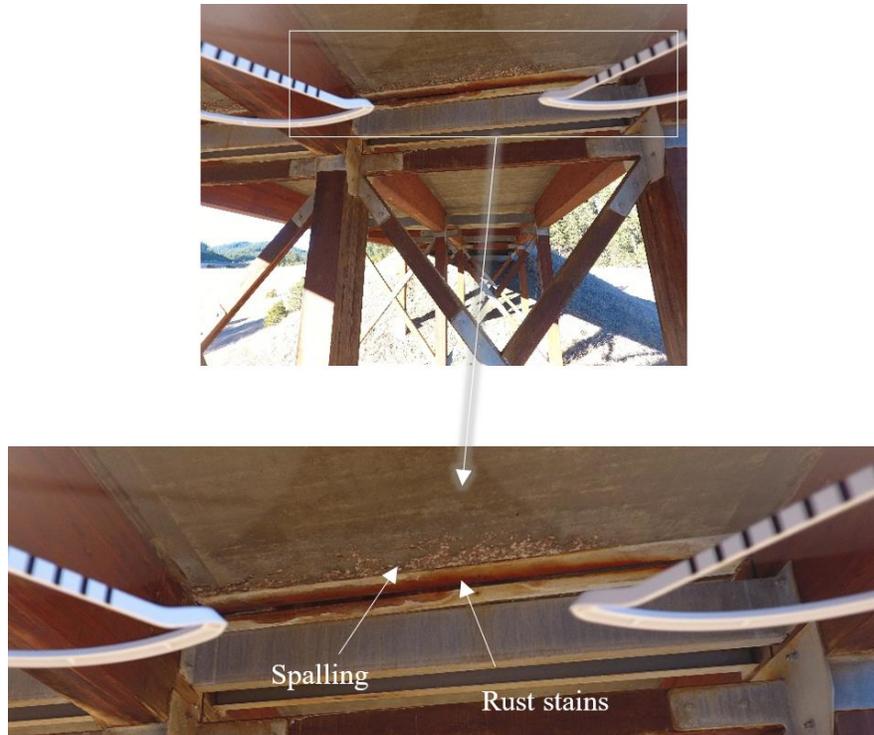
**Fig. 4-5.** Sample damage on Joint 4 captured with UAV (taken by Junwon Seo using UAV).

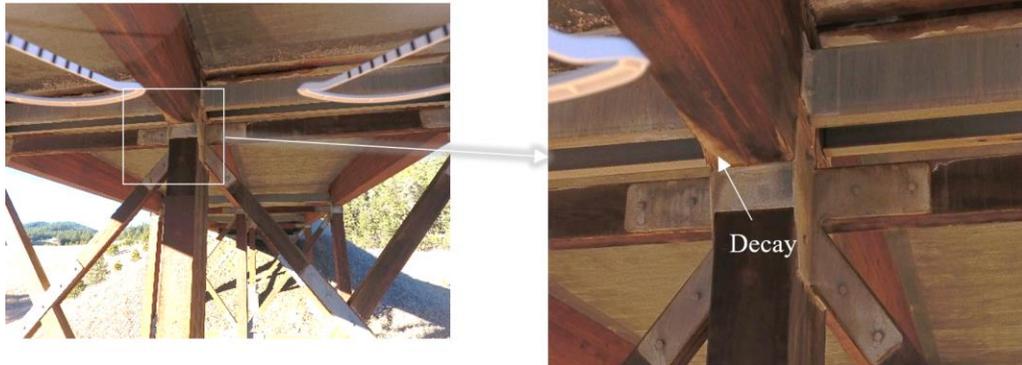
**Fig. 4-6.** Damage identified on Stringer 2 at Joint 4 captured using UAV (taken by Luis Duque using UAV).

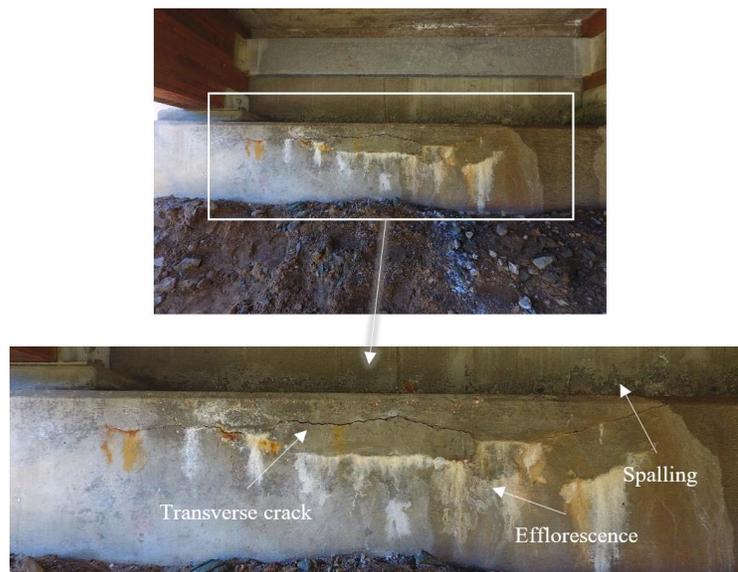
**Fig. 4-7.** Sample abutment damage detected using UAV on Bay 1 at North Abutment (taken by Luis Duque using UAV).

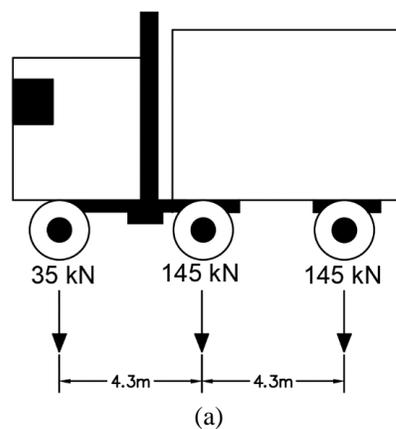
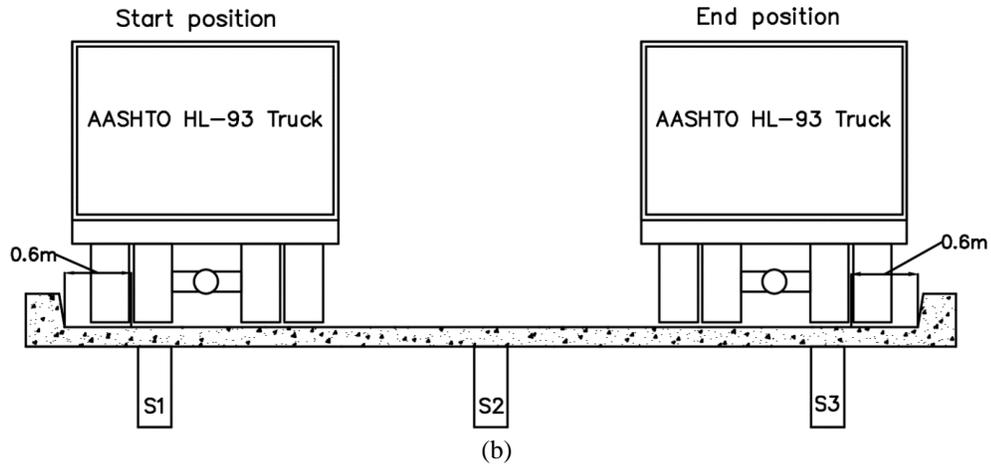
**Fig. 4-8.** Schematics for design truck and truck locations: (a) AASHTO HL-93 truck and (b) sample truck location along the transverse direction of the bridge deck.

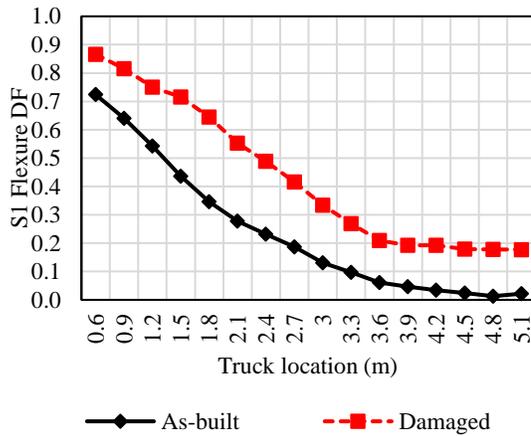
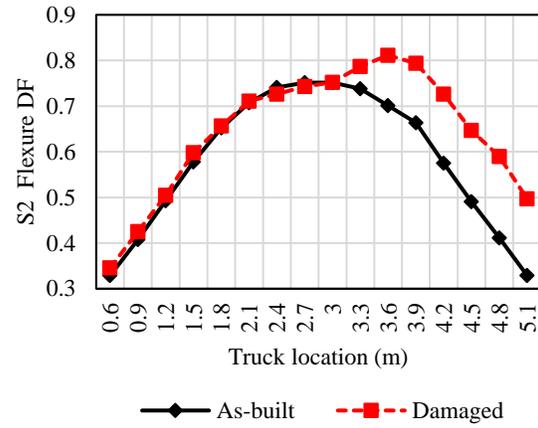
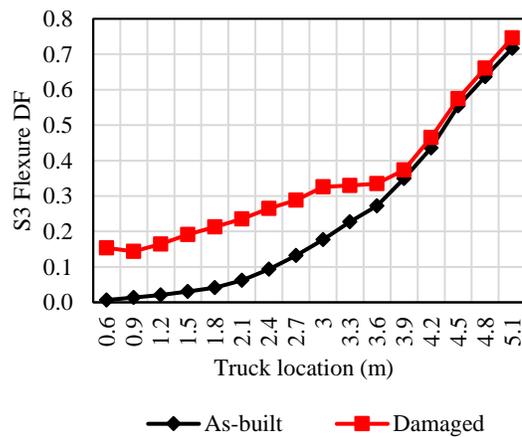
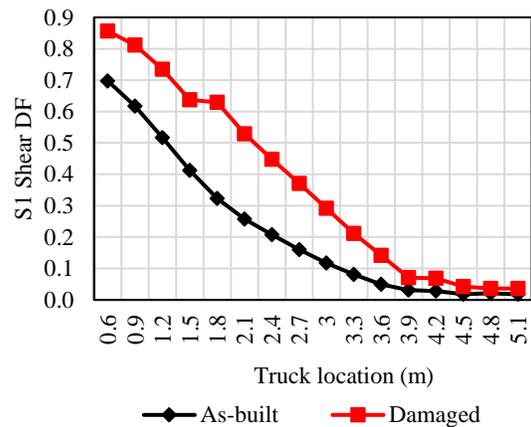
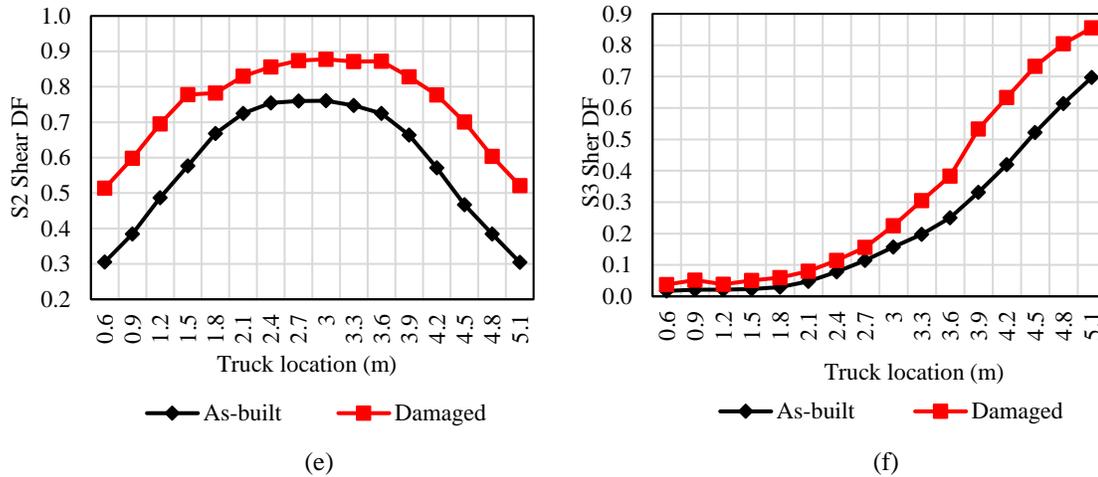
**Fig. 4-9.** Results for flexure and shear DFs with respect to HL-93 truck location: (a) stringer 1 flexure DFs; (b) stringer 2 flexure DFs; (c) stringer 3 flexure DFs; (d) stringer 1 shear DFs; (e) stringer 2 shear DFs; and (f) stringer 3 shear DFs.

increase of shear DFs for the damaged FE model as seen in the plots of **Figs. 4-9d** through **4-9f**.

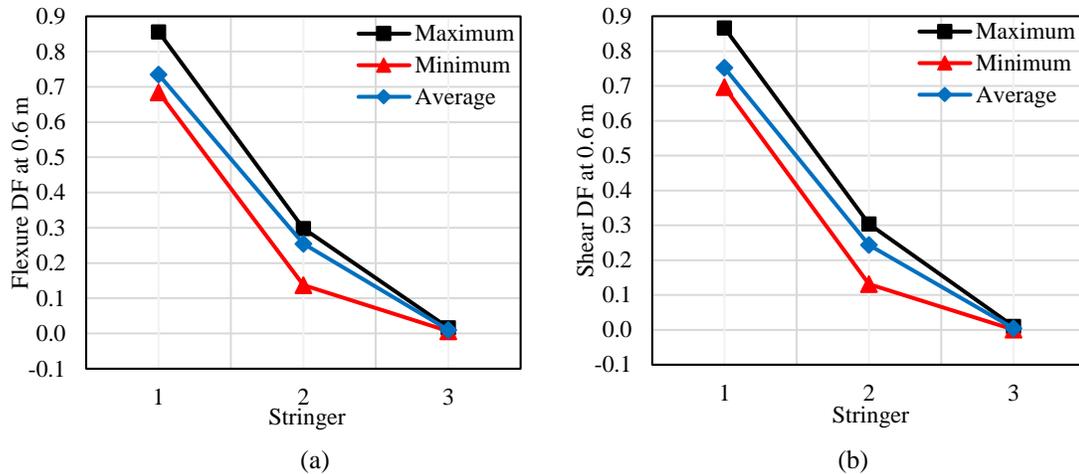
**Fig. 4-10.** Critical section analysis for truck location at 0.6 m from curb: (a) flexural DFs analysis for critical sections and (b) shear DFs analysis for critical sections.

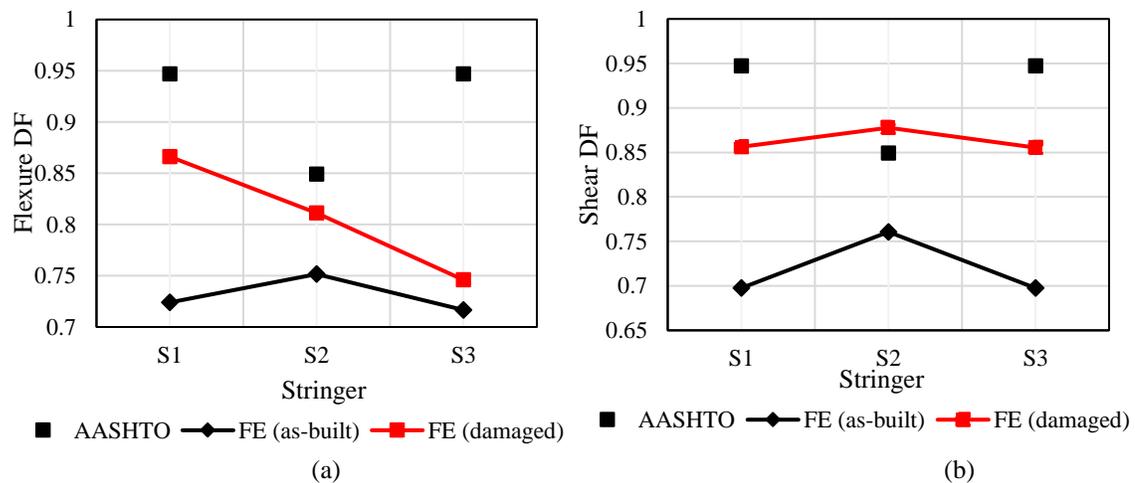
**Fig. 4-11.** Comparison analytical DFs for as-built and damaged models and the AASHTO values: (a) flexure DFs and (b) shear DFs.

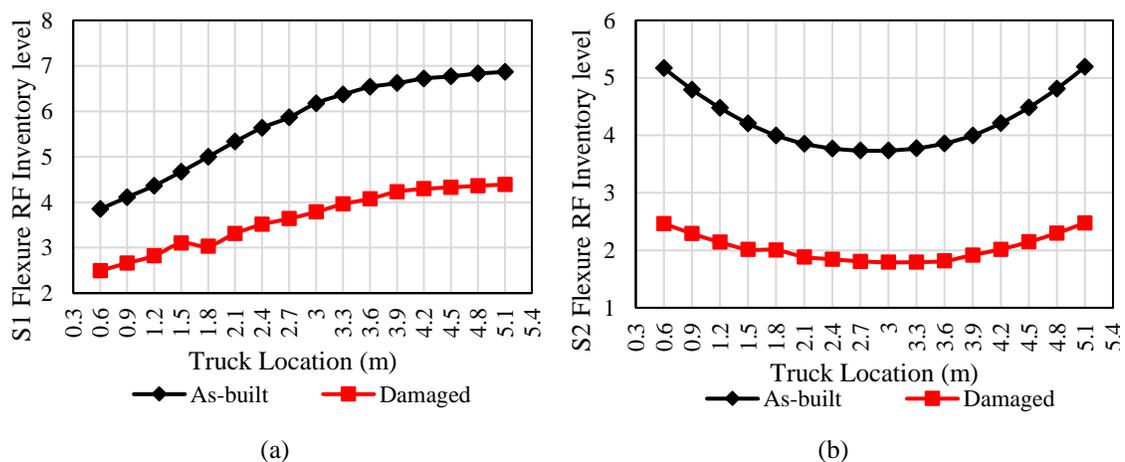
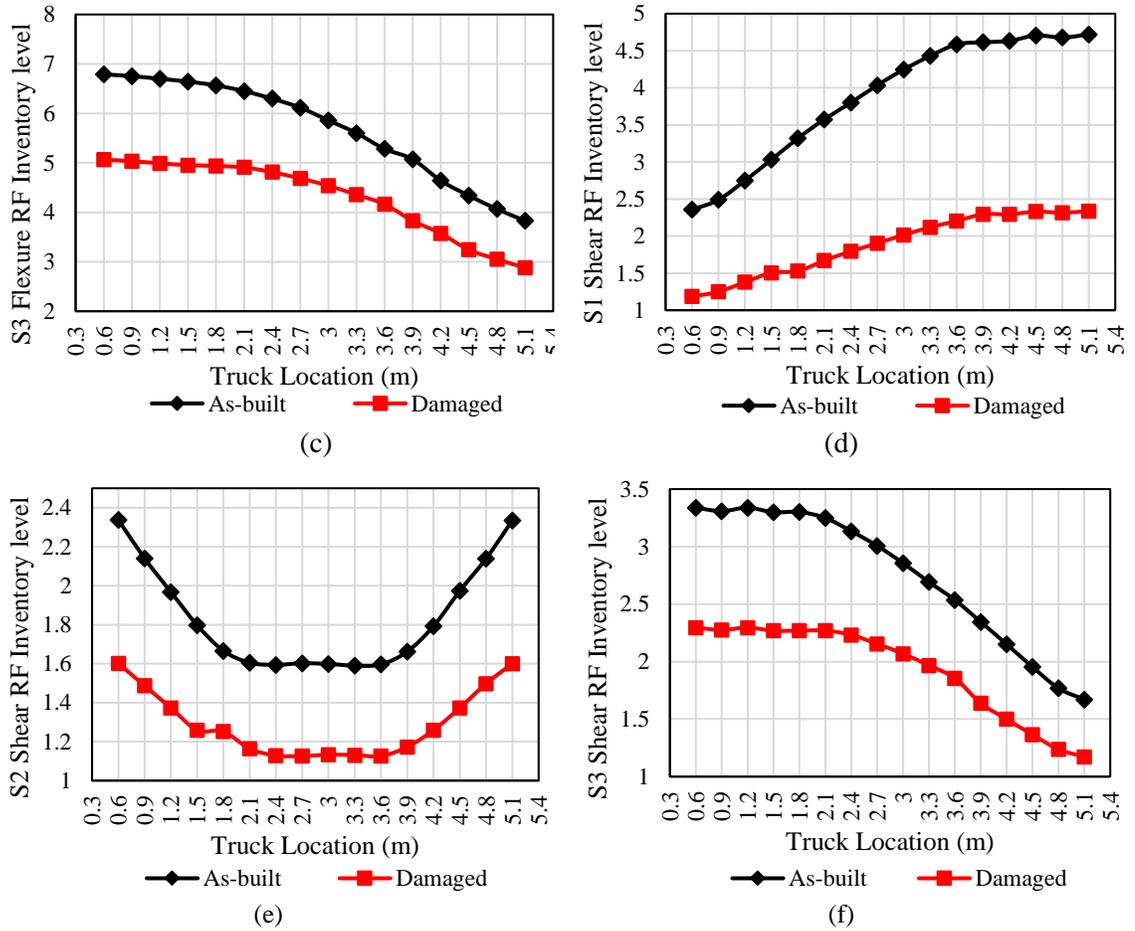
**Fig. 4-12.** Inventory RFs for flexure and shear: (a) stringer 1 flexural RFs for inventory level; (b) stringer 2 flexural RFs for inventory level; (c) stringer 3 flexural RFs for inventory level; (d) stringer 1 shear RFs for inventory level; (e) stringer 2 shear RFs for inventory level; (f) stringer 3 shear RFs for inventory level.

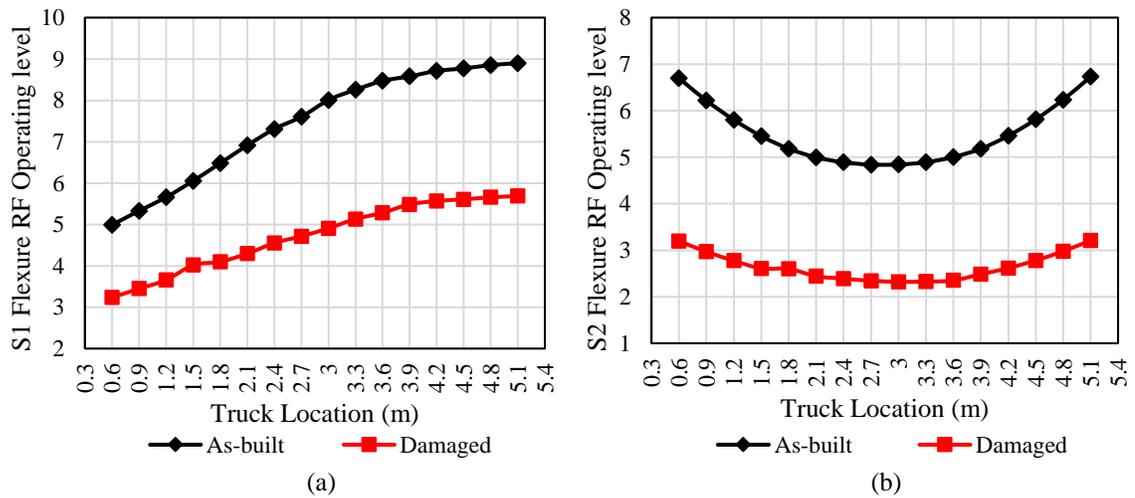
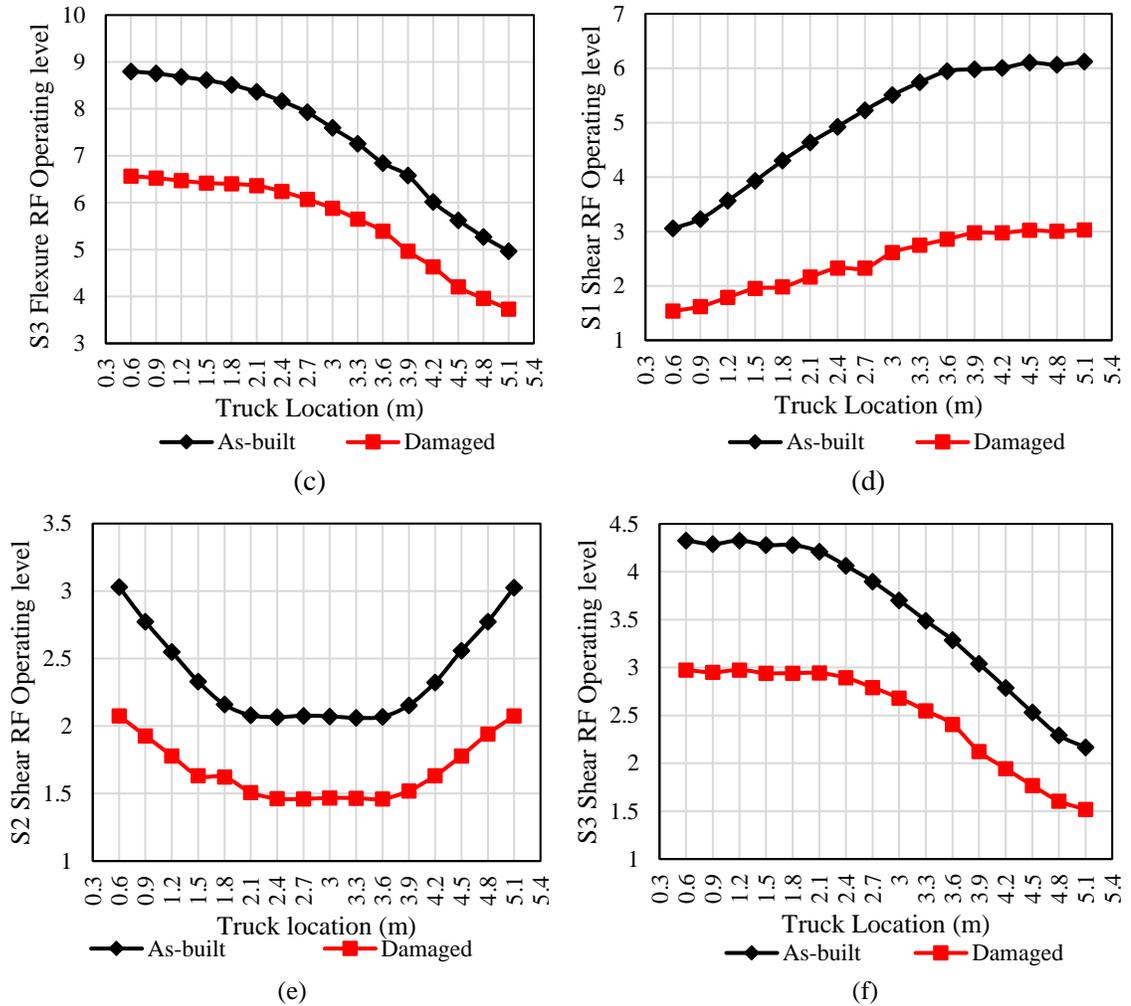
**Fig. 4-13.** Operating level RFs for flexure and shear: (a) stringer 1 flexural RFs for operating level; (b) stringer 2 flexural RFs for operating level; (c) stringer 3 flexural RFs for operating level; (d) stringer 1 shear RFs for operating level; (e) stringer 2 shear RFs for operating level; (f) stringer 3 shear RFs for operating level.

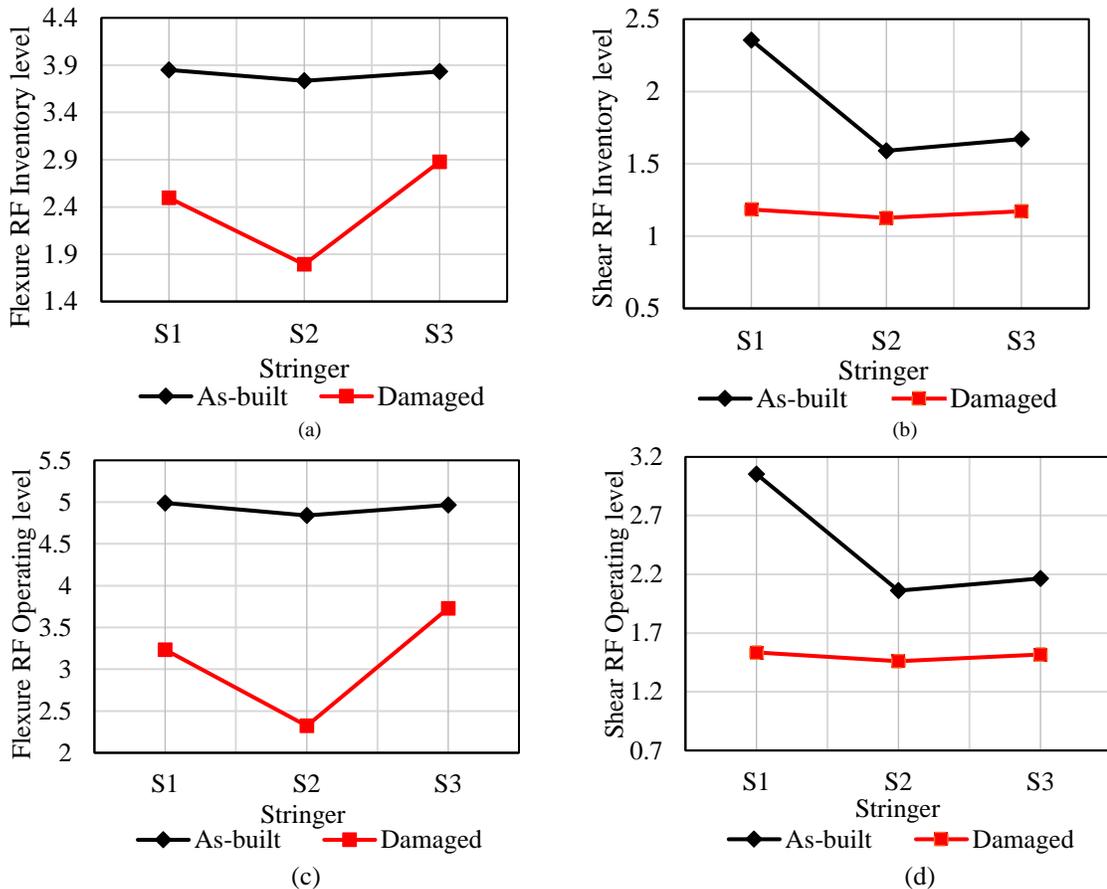
**Fig. 4-14.** Summary of RFs for the inventory and operating level: (a) flexure RFs for inventory level; (b) shear RFs for inventory level; (c) flexure RFs for operating level; and (d) shear RFs for operating level
